15-Passenger Van Safety Review

PAIRED SIDE IMPACT CRASH TESTING of a 15 PASSENGER VAN & an MFAB

INTERNAL RESEARCH REPORT ASFB 11- 05

October 5, 2012

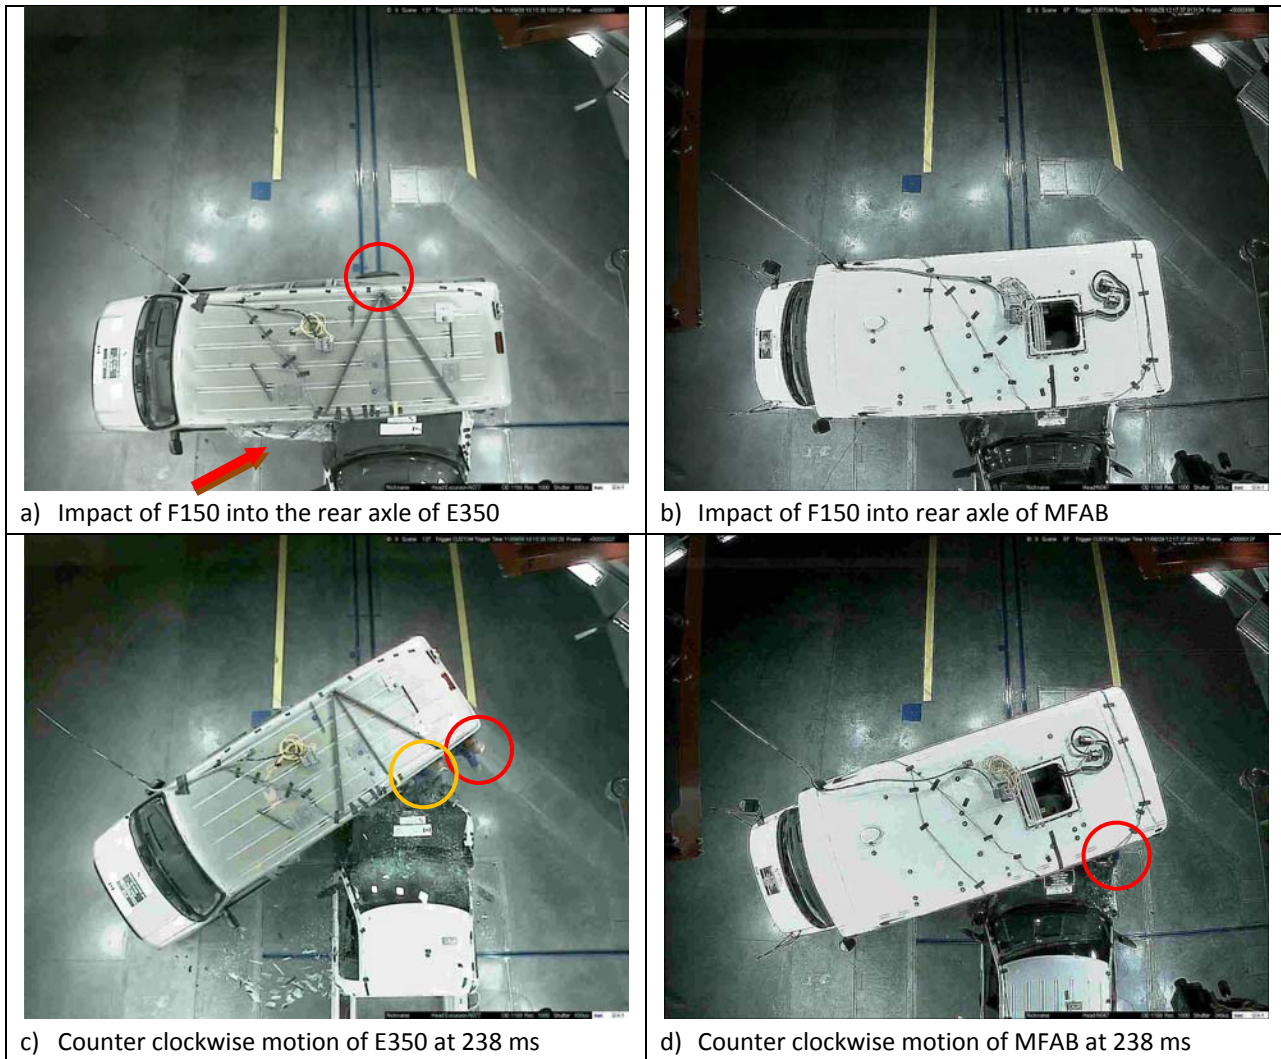
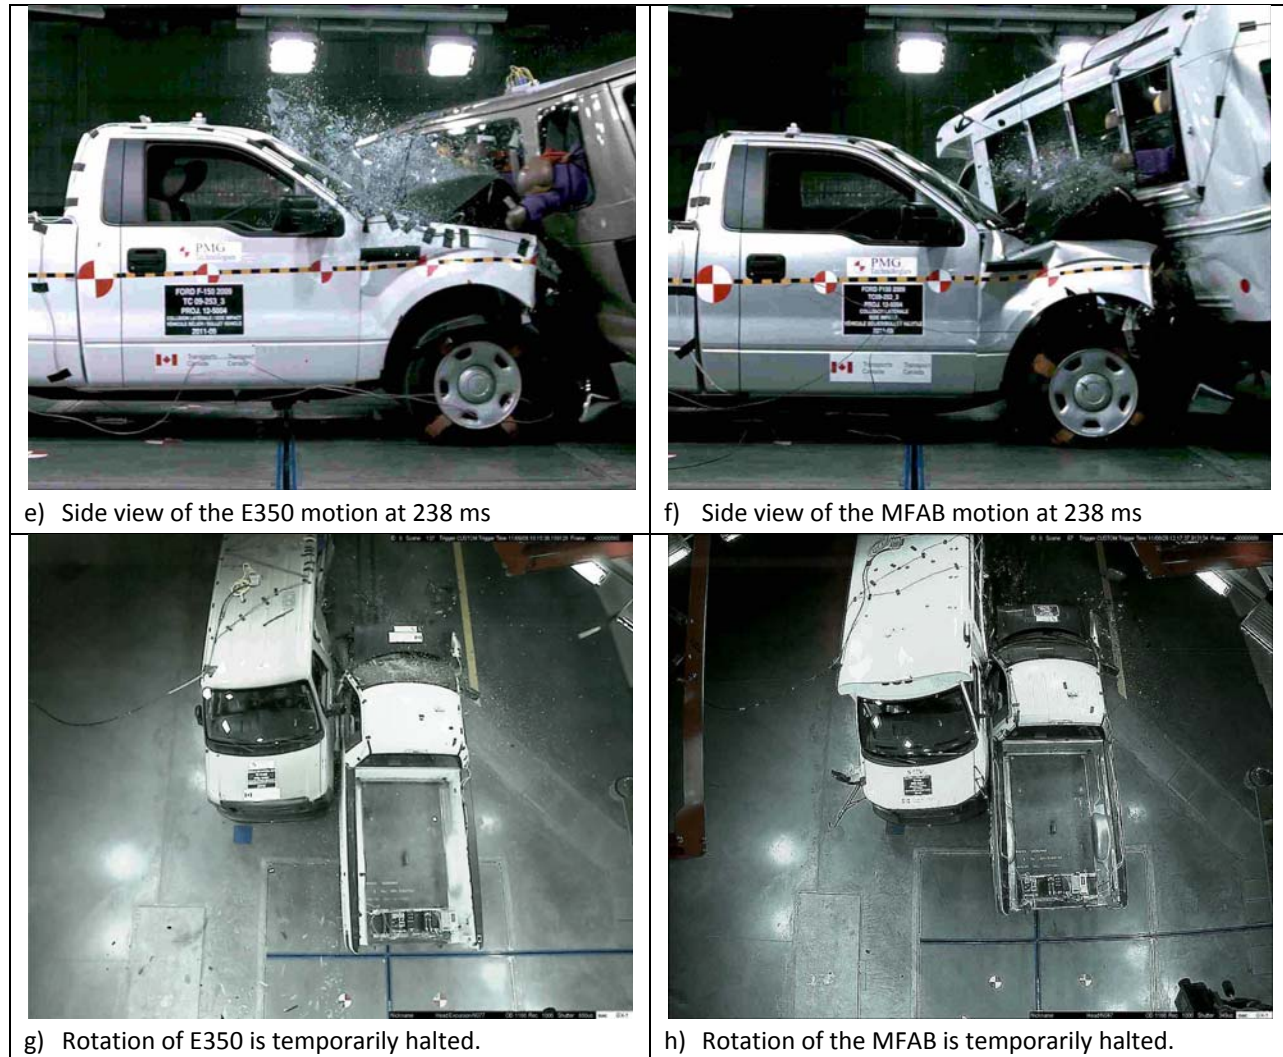
Figure 6. Sequence of motion of the test and bullet vehicles recorded by high speed video cameras.

Figure 6c is a freeze frame obtained as the E350 begins to rotate away from the path of the pick-up truck. The red circle identifies the ejection of the head and upper torso of the WS male dummy that was seated in the rearmost row on the struck side of the van. The orange circle highlights the ejection of the head and left shoulder of the WS RibEye dummy seated in the middle row on the struck side of the van. Figure 6d is a freeze frame of the MFAB obtained at the same moment in time as that shown in 6c. The red circle indicates the location where the dummy arm was ejected through the window. Figure 6e and 6f present the side view of the motion at the same instant in time shown in Figure 6c and d. Both the E350 and the MFAB tip towards the respective bullet vehicle.

The counter clockwise motion is temporarily interrupted by the body of the pick-up truck. The two vehicles become aligned along their longitudinal axis (Figure 6g & h). Each test vehicle continues its rotation to the final resting point as the bullet continues its forward trajectory.

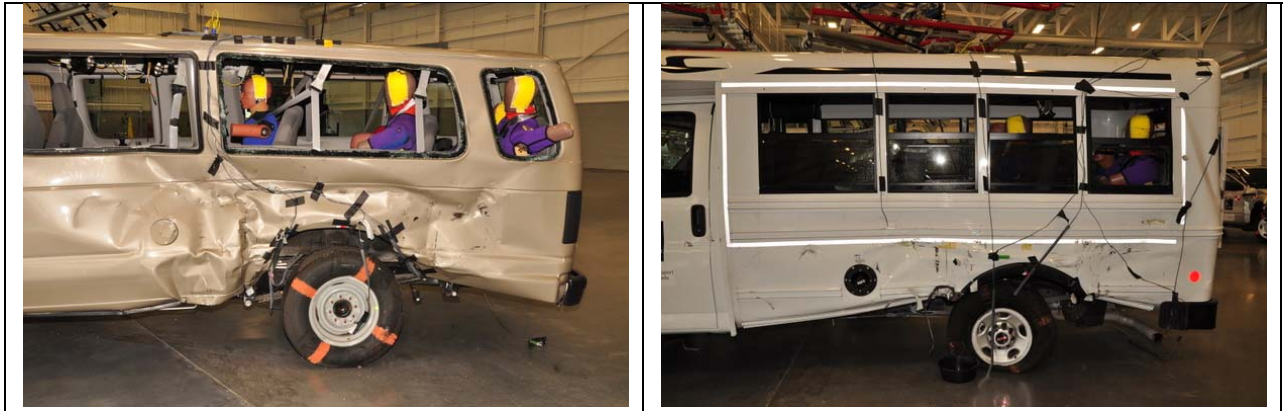
Figure 8. Location of impact point and view of imprint left by the F150 on the E350 (left) and MFAB (right).

Figure 8 and 9 present the location of the impact point and the intrusion that resulted from the collision with the E350 and the MFAB. The intrusion was limited to the area surrounding the left rear wheels in both test vehicles. There is somewhat more deformation observed in the E350 than in the MFAB.

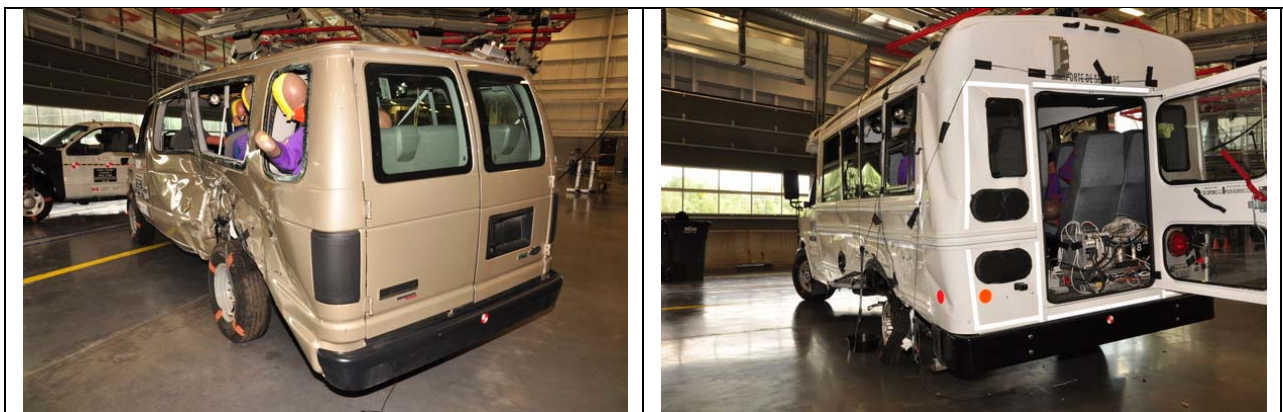
Figure 9. Oblique view of intrusion observed after the tests for the E350 (left) and MFAB (right).

Note that the height of the window openings is similar in both the E350 and the MFAB. Two principal differences are the sizes of the window openings and the frames. The E350 windows, located over the wheel are wider than in the MFAB and cannot be opened. The windows in the MFAB consist of two sections that slide vertically to open. The window edge acts as a cross member that extends horizontally across each window. The effect that these window designs have on occupant kinematics will be discussed in the section describing the results of the occupant kinematics.

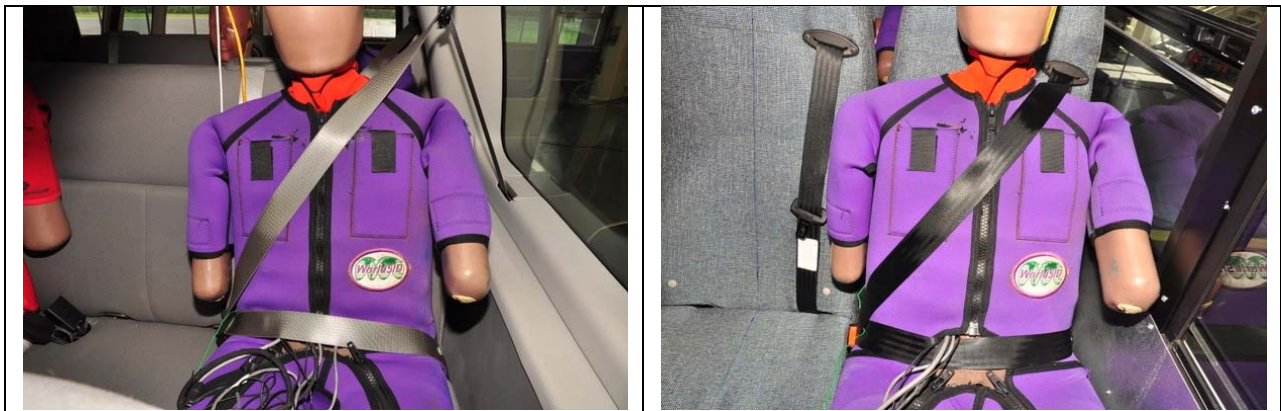
Figure 12. Comparison of interior trim and seatbelt anchorages in the E350 (left) and MFAB (right).

The interior profiles of the struck side walls were different in the E350 and the MFAB. Figure 12 is a front view of the occupant seated in the second row. The E350 has a stepped interior plastic trim which extends to the upper chest, below the axilla (under arm) of the 50th male dummy; the MFAB has no interior trim; the flat wall extends to the lower window frame. In the left side photo of Figure 12, there is a gap between the shoulder and the window in the E350 whereas the dummy shoulder is in full contact with the window of the MFAB seen in the right side photo. The upper belt anchors are mounted in the pillar of the E350 but integrated in the seat of the MFAB.

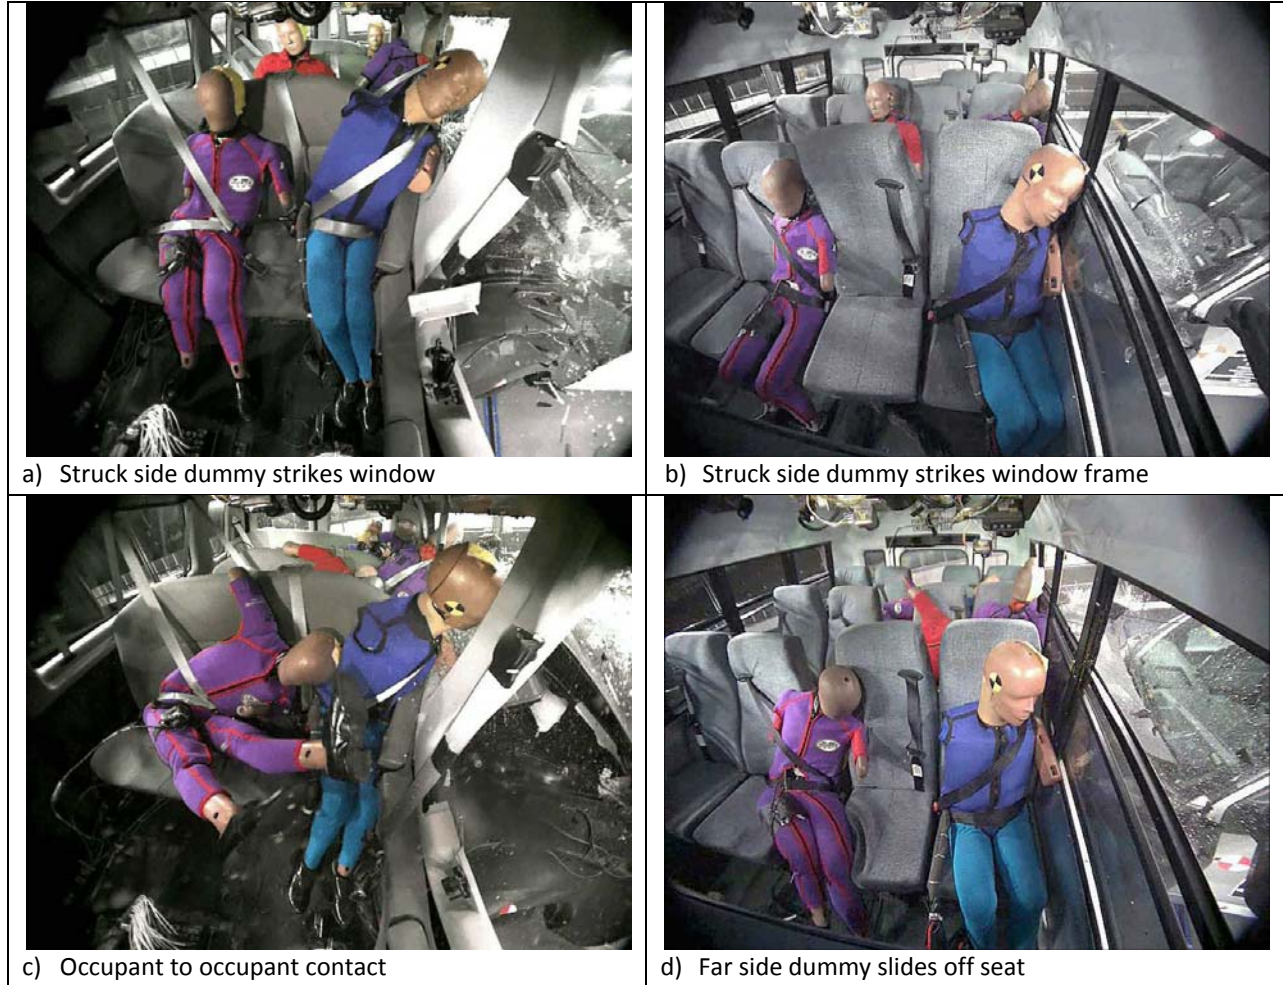
Figure 13. Motion during the crash of front row occupants seated in the E350 (left) and MFAB (right)

The front row contained two dummies representing small women, struck side SID IIs, non-struck side WS 5th. The head of the struck side dummy in the E350 shown in Figure 13 a and c first strikes the window then rolls forward from left to right striking the forward pillar of the window. The thorax and pelvis are in full contact with the interior trim as the upper torso pivots about the window frame. Based on the kinematics observed, there is a potential for head and facial injuries as well as chest and pelvic injuries. Chest injuries may be compounded by the occupant to occupant contact.

The far side dummy in the E350 is projected laterally along the bench, flexes over the seat belt and collides with the struck side occupant. The seat belt migrates and penetrates into the abdominal region as the WS 5th dummy head impacts the struck side dummy. There is potential for serious abdominal injury and lower rib fractures from interaction with the seat belt. There may also be potential for head injury resulting from the collision with the other occupant.

The far side dummy in the MFAB is projected laterally, off the seat and is suspended by the seat belt. There is potential for serious abdominal injury and lower rib fractures from interaction with the seat belt.

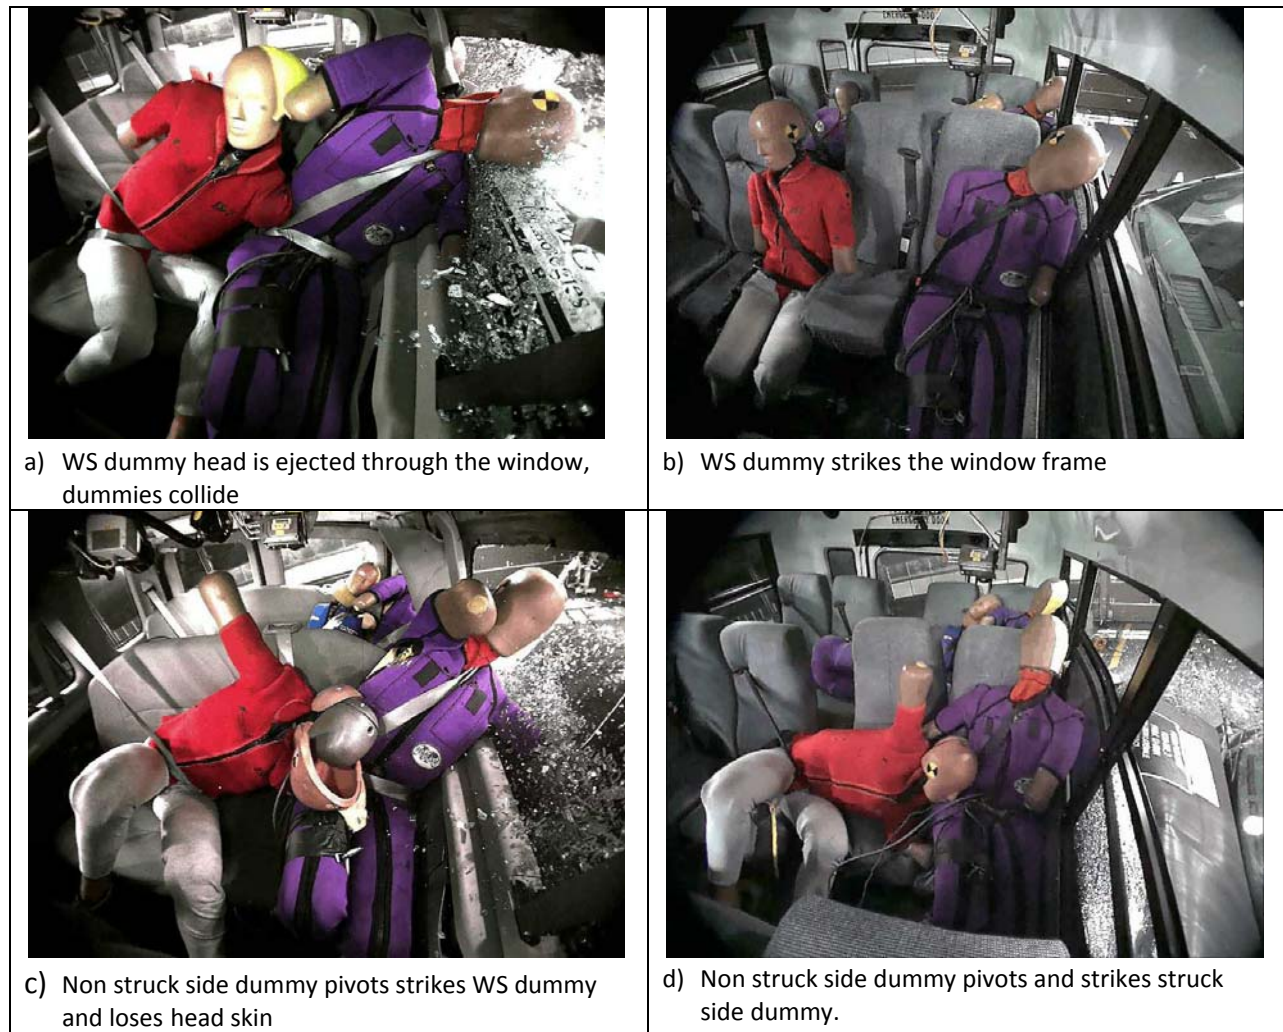
Figure 14. Motion during the crash of the second row occupants seated in the E350 (left) and MFAB (right)

The head of the WS 50th in the MFAB strikes the window frame. This rigid structure prevents the ejection of the dummy head. The shoulder belt penetrates into the neck region. The shoulder is supported by the window and thus appears to act as a blocker preventing direct impact to the thorax. The right side of the WS 50th is struck by the head of the far side occupant. There is potential for head injury caused by the impact with the window frame. Chest and internal organ trauma may result from the impact with the other occupant.

The ES-2re located on the non-struck side of the E350 van is projected laterally into the struck side passenger. The dummy slips out of the shoulder belt early in the event and pivots about the lap and shoulder belt. The seat belt penetrates into the abdominal cavity while the head collides with the lower thorax of the WS 50th. The flesh skin of the dummy is dislodged. Expected injuries resulting from the observed kinematics include head injury, rib fractures and internal organ injury.

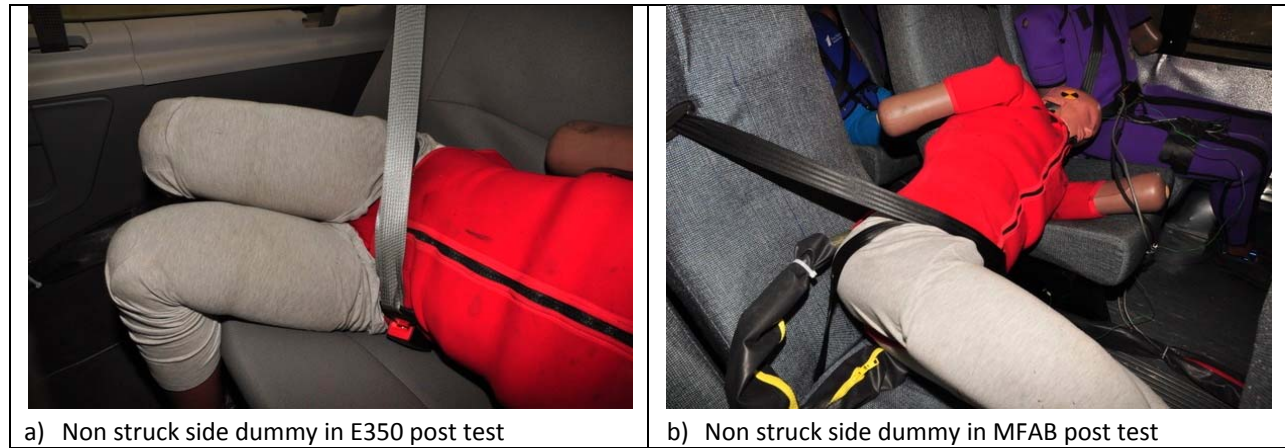
Figure 15. Photos of final resting position of the ES2-re dummy following the test.

The ES-2re seated in the MFAB displays similar kinematics. The dummy translates laterally, off the seat then rotates about the seat belt and strikes the WS 50th with his head. The lap and shoulder belt penetrates deeply between the pelvis and lower ribs. Expected injuries resulting from the observed kinematics would include head injury, rib fractures and internal organ injury. The final positions of the ES2-re in the E350 van and the MFAB, as shown in Figure 15 are quite similar.

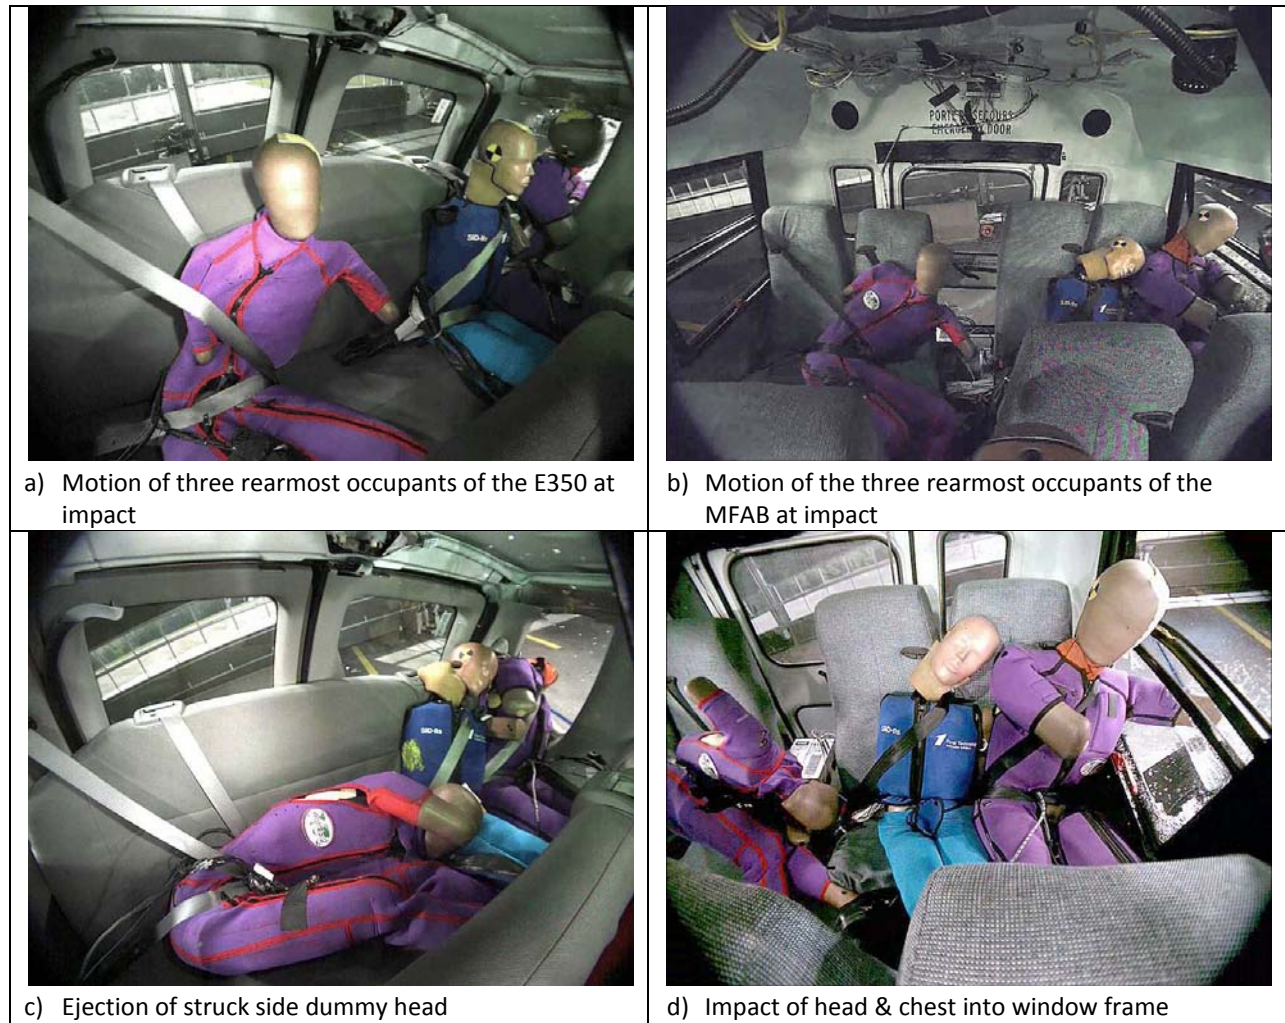
Figure 16. Motion during the crash of the rear most row occupants seated in the E350 (left) and MFAB (right)

At impact, the head of the WS 50th seated on the struck side of the E350 is projected into the rear window. As can be seen in the upper right corner of the image in Figure 16a, the head of the WS 50th strikes the upper window edge as it is ejected through the back window. The dummy pivots about the bottom window edge, such that both the head and left shoulder are outside the vehicle. The head can also be seen from the exterior. The red circle in Figure 6c highlights the ejected head as the vehicle began its counter clockwise rotation. The shoulder belt, while taut against the neck is ineffective at restraining the upper torso. The chest makes full contact with the interior trim and side structure of the van. This can be better visualized in the post test photos shown in Figure 17. The kinematics of this occupant suggest that there is a high risk of head injury, risk of laceration to the head and neck as well as an elevated risk of organ trauma, chest and upper extremity injury.

The head of the WS 50th seated in the MFAB struck the window frame cross member at impact as shown in Figure 16b. In Figure 16d one can observe the distortion of the window frame and the impact of the dummy shoulder and arm shattering the windows. Contact was observed between the chest of the dummy and the lower edge of the window. Impact occurred at an angle. The standard two dimensional dummy rib instrumentation contained in this version of the WS50th cannot deflect in this direction. As can be seen in Figure 17b above, the bottom edge of the window in the MFAB is unprotected and contains a handle to release the window in emergency situations. The kinematics for this occupant indicate that there would be a risk of head injury, a risk of head and/or neck lacerations and a possibility of chest and or organ trauma. Upper extremity injuries involving fractures and/ or lacerations to the arm and shoulder may occur.

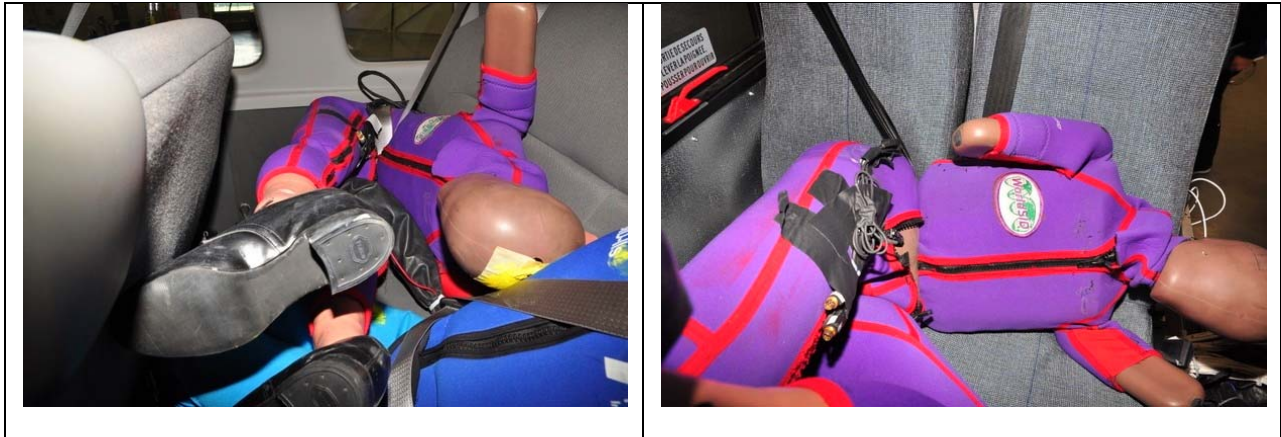
Figure 18 Photos of final resting position of far side dummy seated in rear row of E350 (left) and MFAB (right).

In both the E350 and the MFAB the far side occupant is not effectively restrained by the lap and shoulder belt. In both crashes the dummy is observed to slip out of the belt as she is projected towards the impact zone. The dummy rotates about the seat belt striking the chest of the SIDII in the case of the E350. If one looks closely at the images in Figure 16 c & d it is possible to observe the extreme penetration of the seat belt into the abdominal cavity. In fact, the two crash tests severed the dummy lower spine. In the MFAB she cannot reach the SIDII but essentially ends up with her head on the floor between the seats as shown in the post test photos below in Figure 18. In both vehicles there is high risk of head injury, a high risk of chest fractures and internal organ injury as well as a potential for lower spine injuries.

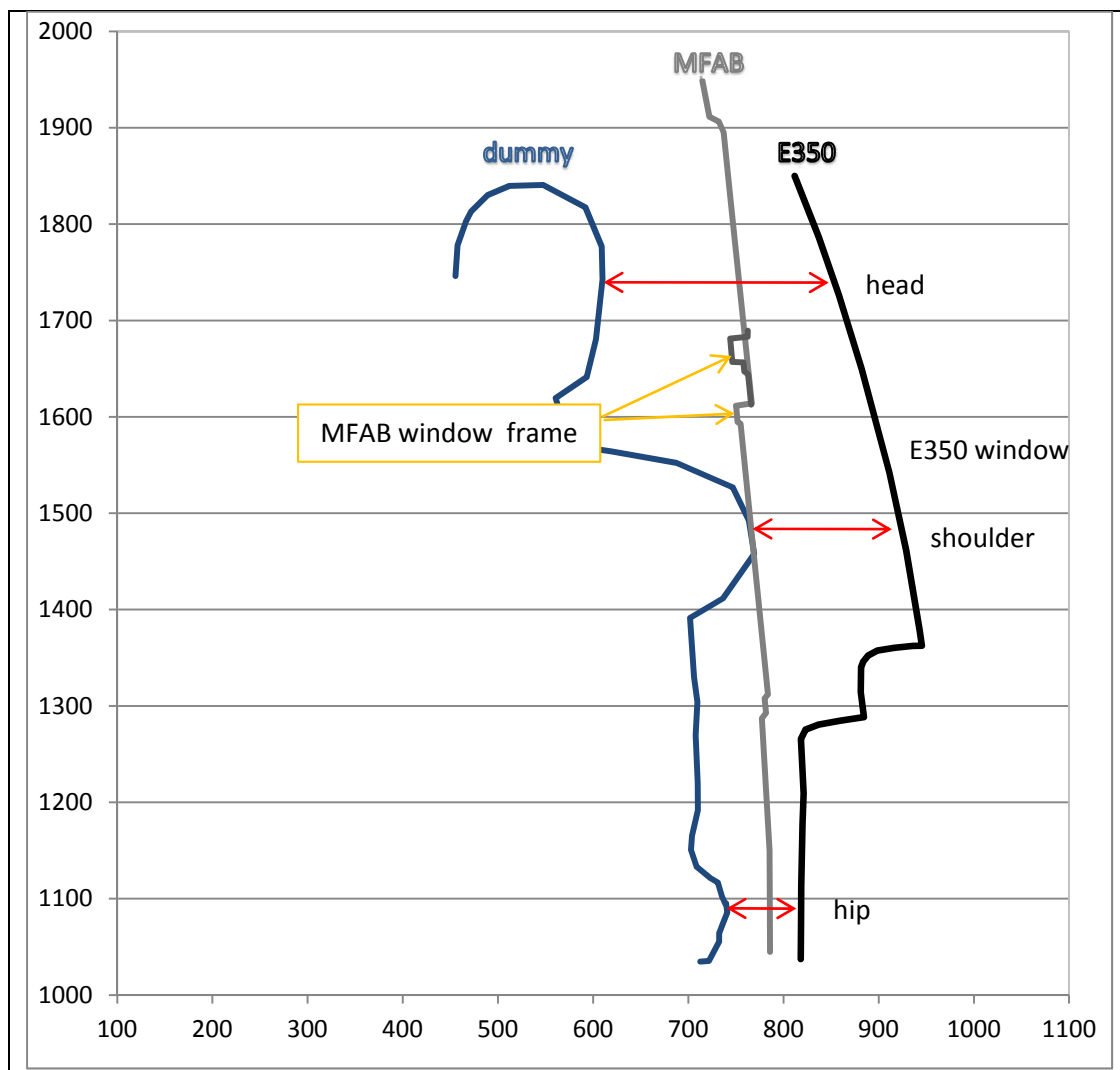
Figure 19. Profile of the interior trim and window of the E350 van (black) and the interior wall of the MFAB (grey).

Figure 19 compares the interior trim of the E350 van to the sidewalls of the MFAB with respect to the outboard struck side dummy profile. The two profiles are very different. The sidewalls of the E350 illustrated by the black line are covered with a plastic trim. The trim extends inboard, approximately 120 mm from the bottom of the window and forms two stepped horizontal surfaces, each approximately 60 mm wide. The lower horizontal surface or ledge appears to serve as an armrest. The window, also shown in black has a slight curvature with an upper edge that is in-line with the lower interior trim. The interior of the MFAB illustrated by the grey line is a flat wall with no interior trim. The windows are almost vertical.

Of significance in the outline views shown above is the distance between the outboard struck side passenger, outlined in blue and the trim or sidewall of the respective vehicles. The greater the distance between an occupant and the interior surface, the greater the velocity with which the body of the occupant will impact that surface. Irregular surfaces created by some armrests or interior trims as observed for example, in the E350, can exacerbate the relative displacement of body segments and can increase the risk of injury. In the E350 the head and shoulder are projected into the triangular shaped void that is formed by the window and interior trim and shown in Figure 19. This means that the head and upper thorax can pivot about the trim. The head strikes the window with increased speed and the ribs are in direct contact with the intruding trim. In the MFAB, the kinematics are different because the flat wall surface prevents the struck side dummy from pivoting. Since the side of the dummy is already in contact with the sidewall prior to the crash, there is very little space for the dummy to accelerate. The WorldSID translates laterally compressing the shoulder, while the hips are rapidly blocked by the sidewall and the head strikes the window frame. The bony protuberance of the shoulder represented in this case by the hardware in the dummy shoulder and pelvis reduce the extent of direct contact with the ribs.
