Four Square Home Inspections

Page 1 of 78
Sample Report - 2017.pt6

Property Address 1223 Any Street

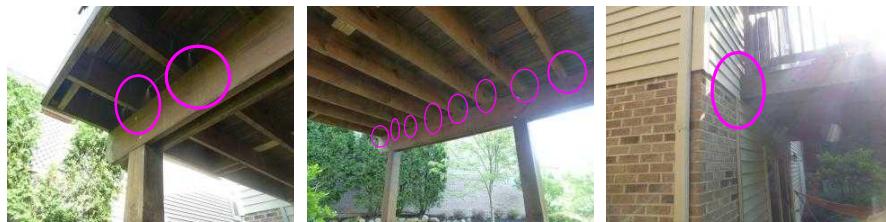
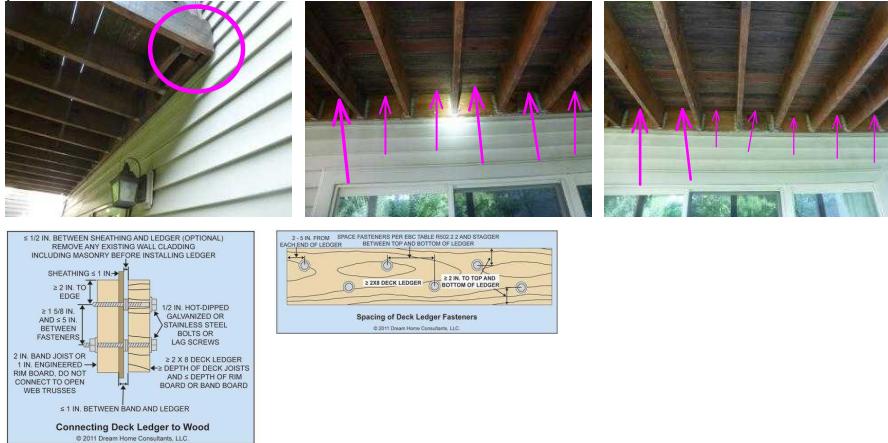
detail. Contemporary deck construction requirements require two (or four) alternative lateral force connectors to connect the deck structure to the house structure to prevent lateral loading of the deck and rotation of the ledger. Simpson Strong-Tie makes two devices that are approved for new installations and retrofit applications. The DTT2Z is a deck tension tie that, when used in a pair, meets the 3,000 pound lateral load specification. The second alternative where four units would be required is identified as the DTT1Z. Two or four (depending on connector) connectors should be retrofitted to this deck for safety. As an alternative, a letter signed and stamped by a licensed structural engineer certifying the structural integrity of this deck, the deck ledger and deck ledger connection may provide a measure of legal protection in the event of a deck failure. A qualified deck contractor will be familiar with the American Wood Council's Design for Code Acceptance DCA-6 document which, along with the International Residence Code, details installation requirements and specifications for these lateral load connectors. Sample locations shown only. The American Wood Council (see <http://www.awc.org/codes-standards/publications/dca6>) has long published and revises as appropriate, the document entitled DCA-6 and known as the "Prescriptive Residential Deck Construction Guide." While this guide is technical in nature, by design, it is also a ready reference for a homeowner wishing to better understand how their deck should be constructed. You may also wish to consult Simpson Strong-Tie (<https://www.strongtie.com/resources/literature/deck-connection-fastening>) for supplemental information concerning the hardware used for proper deck construction. However, with all of this said, this deck does not, at the time of the inspection, evidence structurally shifting or ledger detachment. Nonetheless, the long-term viability, performance and safety of this deck structure may require repairs as outlined above. I suggest monitoring the deck at the house side for evidence of change. If such change occurs, I recommend that you consult a licensed structural engineer for an evaluation.

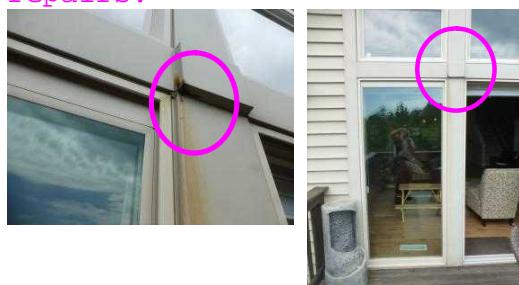
5. Trim: Aluminum coil wrap Evidence of water entry within or behind trim. Evidence of ferrous metal (rust stains). Suggest a qualified siding contractor investigate source of water entry and estimate repairs.

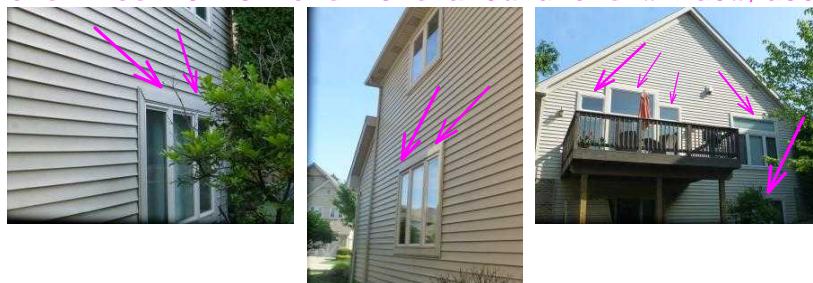
7. Flashings: Window and door head flashing Head flashings are not present at window and door penetrations through the exterior siding (sample locations shown only). Head flashings are used to direct water away from openings such as windows and doors. Head flashings should be installed with a positive slope to the exterior. The cladding above the head flashing should never rest on the flashing as this leads to problems with the flashing being bent in the wrong direction and sloped back towards the building. Head flashings

should extend laterally past the opening on either side. This flashing is particularly important when the window or door is not protected by an overhead roof, soffit or cantilevered projection. Sample locations shown only. While head flashings can be installed after the fact (with siding removal), it is generally not recommended unless visual or other evidence suggests water entry to the interior of the home around the window/door.

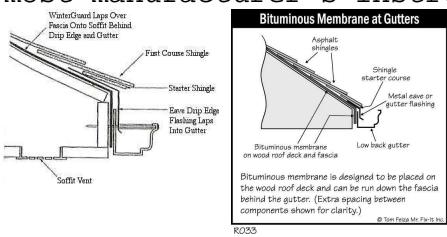
6. Ice Guard Installed to protect sheathing? Ice Guard has been installed and adhered to top face of drip edge. While this approach works, it is not the best practice for ice dams can still lift the drip edge and damaged the underlying sheathing (or cause interior collateral damage).
7. Ice Guard installed behind gutter? Yes No The adjacent illustrations suggest how Ice Guard should properly be installed behind a drip edge/gutter in accord with most manufacturer's instructions.

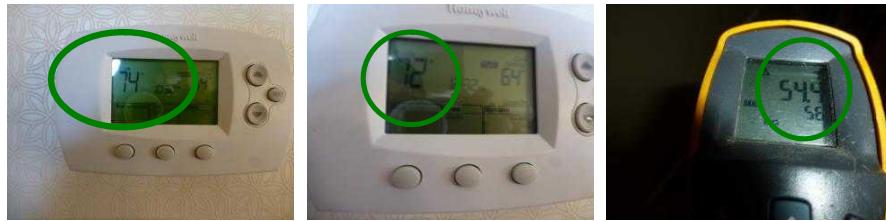
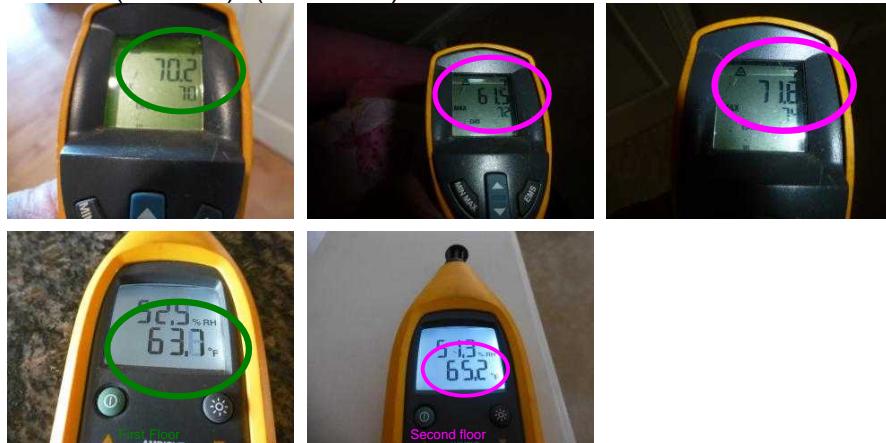
7. Temperature Differential (if tested): 10-16 degrees The nominal supply temperature from a properly functioning air conditioning unit is typically about 55 degrees when measured closest to the evaporation coil. Measurements made from registers downstream (room registers for example and particularly registers located farther from the furnace as on the second or third floors) of the coil (which is located in the plenum of the furnace) will be slightly warmer particularly in the early stages of cooling. Supply temperatures notably higher than 55 degrees suggest that the air conditioning system is not functioning at capacity and repair or replacement should be expected. The air conditioning performed adequately on the first floor but the second floor was measurably warmer than the first. As noted elsewhere, the system may simply need to be re-balanced to drive more cool to the second floor. Part of the explanation for the warm second floor may be explained by the open floor plan that allows the first floor cool air to "push" the warm air to the second floor. Again, a system balancing may compensate for this cooling concern and/or the system may require the service of a licensed HVAC technician.

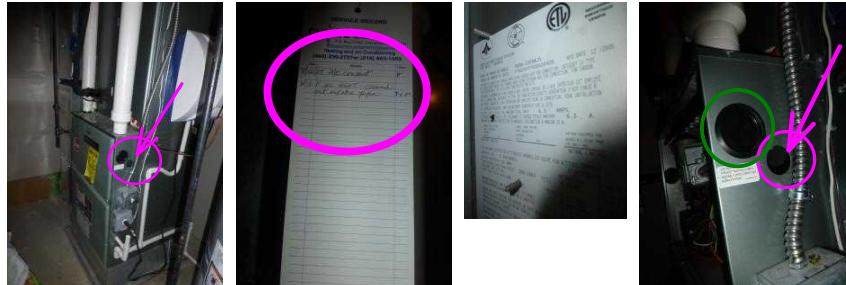
1. Heating System Operation: Adequate at time of inspection. Plug to seal the combustion compartment is missing. Suggest a licensed HVAC technician install a replacement plug to improve (correct) the energy efficiency of this furnace. Routine and recent furnace/boiler service by a licensed HVAC contactor should be so indicated by the presence of such a service sticker. No such service sticker is present suggesting that this furnace/boiler has not enjoyed recent or routine inspections by licensed HVAC technicians. Recommend regular inspections of furnace unit and heat exchanger (for carbon monoxide emissions), I strongly recommend that you engage a licensed HVAC contractor to perform a baseline (initial) service inspection on the furnace and air conditioning equipment (for the air conditioning equipment when the season permits with weather at or above 60 degrees) as appropriate to assure complete functionality and safety. This licensed HVAC service inspection should involve an evaluation of the heat exchanger (not inspected and beyond the scope of a traditional general home inspection) as well as the air conditioning evaporator coil. This would be a good time to have the evaporator and condensing coils professionally cleaned as well.

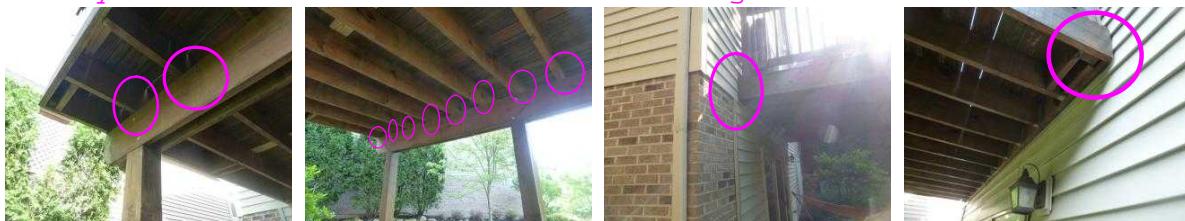
applies to shorter deck joists and the closer spacing to longer deck joists. Lag screws need closer spacing than bolts. The fasteners used for this deck installation do not comport with contemporary safety requirements. See the attached diagrams for additional detail. Contemporary deck construction requirements require two (or four) alternative lateral force connectors to connect the deck structure to the house structure to prevent lateral loading of the deck and rotation of the ledger. Simpson Strong-Tie makes two devices that are approved for new installations and retrofit applications. The DTT2Z is a deck tension tie that, when used in a pair, meets the 3,000 pound lateral load specification. The second alternative where four units would be required is identified as the DTT1Z. Two or four (depending on connector) connectors should be retrofitted to this deck for safety. As an alternative, a letter signed and stamped by a licensed structural engineer certifying the structural integrity of this deck, the deck ledger and deck ledger connection may provide a measure of legal protection in the event of a deck failure. A qualified deck contractor will be familiar with the American Wood Council's Design for Code Acceptance DCA-6 document which, along with the International Residence Code, details installation requirements and specifications for these lateral load connectors. Sample locations shown only. The American Wood Council (see <http://www.awc.org/codes-standards/publications/dca6>) has long published, and revises as appropriate, the document entitled DCA-6 and known as the "Prescriptive Residential Deck Construction Guide." While this guide is technical in nature, by design, it is also a ready reference for a homeowner wishing to better understand how their deck should be constructed. You may also wish to consult Simpson Strong-Tie (<https://www.strongtie.com/resources/literature/deck-connection-fastening-guide>) for supplemental information concerning the hardware used for proper deck construction. However, with all of this said, this deck does not, at the time of the inspection, evidence structurally shifting or ledger detachment. Nonetheless, the long-term viability, performance and safety of this deck structure may require repairs as outlined above. I suggest monitoring the deck at the house side for evidence of change. If such change occurs, I recommend that you consult a licensed structural engineer for an evaluation.

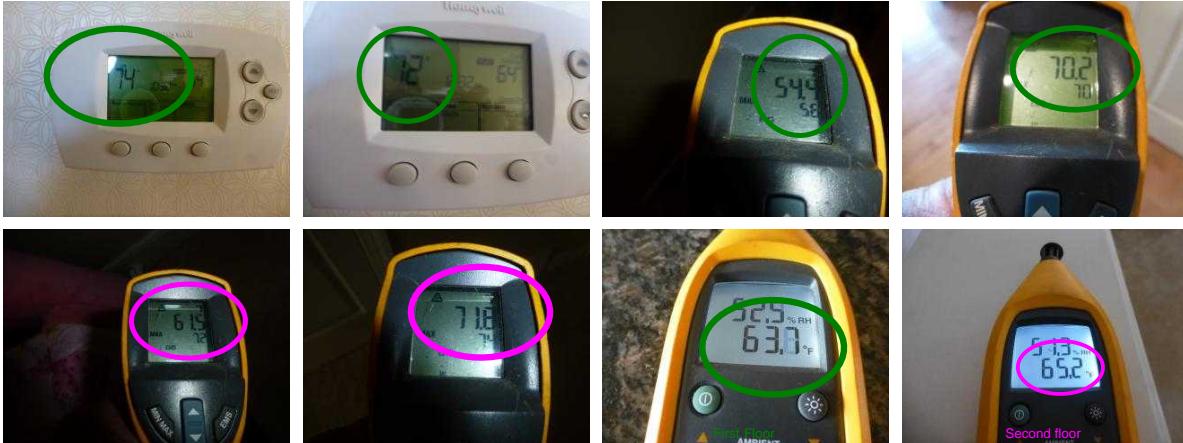
17. Rear yard AC System Temperature Differential (if tested): 10-16 degrees The nominal supply temperature from a properly functioning air conditioning unit is typically about 55 degrees when measured closest to the evaporation coil. Measurements made from registers downstream (room registers for example and particularly registers located farther from the furnace as on the second or third floors) of the coil (which is located in the plenum of the furnace) will be slightly warmer particularly in the early stages of cooling. Supply temperatures notably higher than 55 degrees suggest that the air conditioning system is not functioning at capacity and repair or replacement should be expected. The air conditioning performed adequately on the first floor but the second floor was measurably warmer than the first. As noted elsewhere, the system may simply need to be re-balanced to drive more cool to the second floor. Part of the explanation for the warm second floor may be explained by the open floor plan that allows the first floor cool air to "push" the warm air to the second floor. Again, a system balancing may compensate for this cooling concern and/or the system may require the service of a licensed HVAC technician.

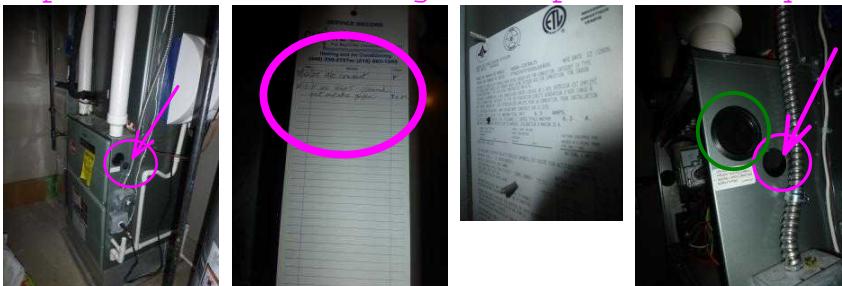
19. Basement utility room Heating System Heating System Operation: Adequate at time of inspection Plug to seal the combustion compartment is missing. Suggest a licensed HVAC technician install a replacement plug to improve (correct) the energy efficiency of this furnace. Routine and recent furnace/boiler service by a licensed HVAC contractor should be so indicated by the presence of such a service sticker. No such service sticker is present suggesting that this furnace/boiler has not enjoyed recent or routine inspections by licensed HVAC technicians. Recommend regular inspections of furnace unit and heat exchanger (for carbon monoxide emissions), I strongly recommend that you engage a licensed HVAC contractor to perform a baseline (initial) service inspection on the furnace and air conditioning equipment (for the air conditioning equipment when the season permits with weather at or above 60 degrees) as appropriate to assure complete functionality and safety. This licensed HVAC service inspection should involve an evaluation of the heat exchanger (not inspected and beyond the scope of a traditional general home inspection) as well as the air conditioning evaporator coil. This would be a good time to have the evaporator and condensing coils professionally cleaned as well.

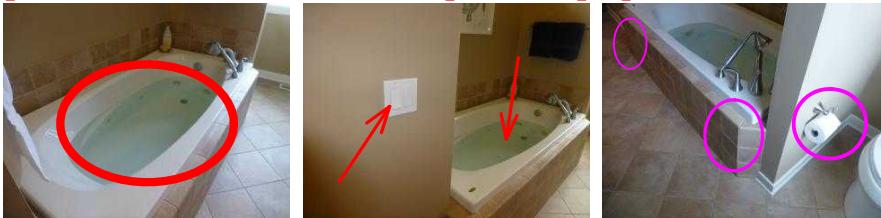
Suggest that the seller identify for you the presence of a removable service panel or their method of prior equipment service.

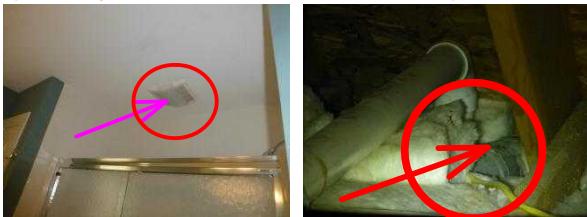
6. Second floor guest bathroom Bathroom Ventilation: Bath exhaust fan/light unit Light inoperative at time of inspection. Bath exhaust fan termination could not be determined with precision for fan/ducting is buried in insulation. However, evidence suggests bath fan is vented to soffit. [Bath fans to soffit]Bathroom exhaust fans should be vented to exterior to prevent condensation, mold growth and potential structural damage to attic spaces and roofing surfaces. Bath fans can be vented through side walls, if the duct run is less than 15' or through the roof to a dampered roof or soffit cap (as would be necessary on a hip style roof). Bath fan appears to be vented to attic or soffit vent (no dampered roof or side wall cap could be located; recommend qualified contractor investigate and re-terminate bath exhaust fan to appropriate dampered cap (roof, soffit or sidewall)).
