SAMPLE INSPECTION REPORT

346 Nowhere Drive, Birmingham, AL 35007

Inspection Date:
2/14/2014

Prepared By:
Goodsell Home Inspections, LLC
Alabaster, AL 35007
(205) 369-9856
gcci10@aol.com

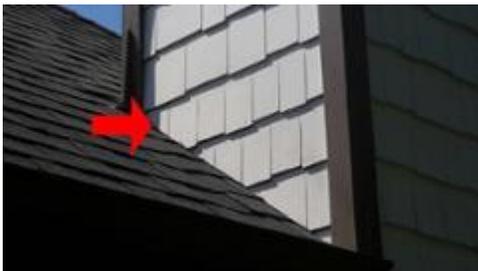
Remove abandoned TV dish bracket and caulk bolt holes.
Repair: The clearance at the siding at the roof is insufficient. This condition leaves the siding vulnerable to rot. This detail is usually repaired when siding needs repair or replacement or when re-roofing work is performed.
Repair: The siding base flashing is rusting. It should be prepped, primed and painted to extend its useful life span.
Repair: The flashing is loose and should be caulked between the brick and the metal flashing to avoid leaks. It is not recommended that the flashing be caulked between the siding and the metal. This would negate the purpose of the flashing altogether.
Portions of the roof were viewed from the ground. Some sections of the roof could not be viewed.

Siding Clearance Is Lacking

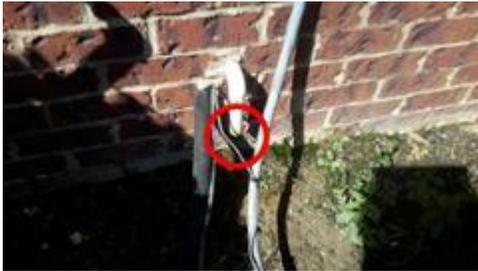
Repair: The discharge location of the condensate line for the air conditioning system should be improved. It needs to be extended away from the house to avoid attracting termites to the home.

Condensate Discharge Location Poor

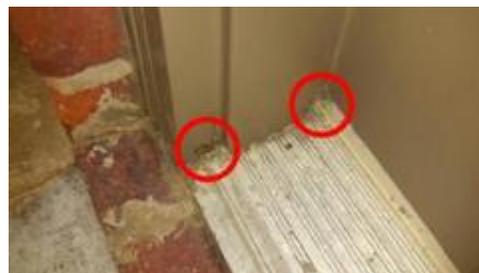
Minor Wood Decay At Door Jamb Noted

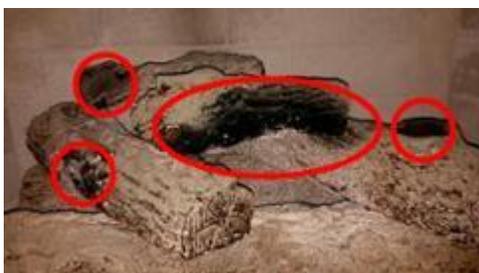
Improve: Seal around the gas line at the fireplace fire box wall penetration.
Gas logs appear to be generating soot.

Gas Logs Generating Soot
