# Guardian Home Inspection Property Inspection Report

123 Southern California , Sample Report , Ca. 90000

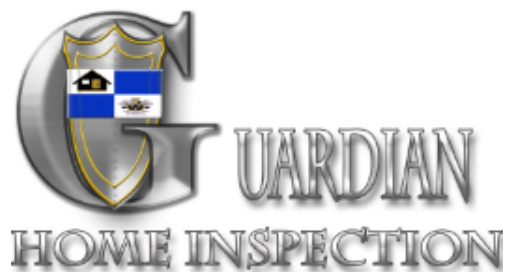
# Inspection Site and Details

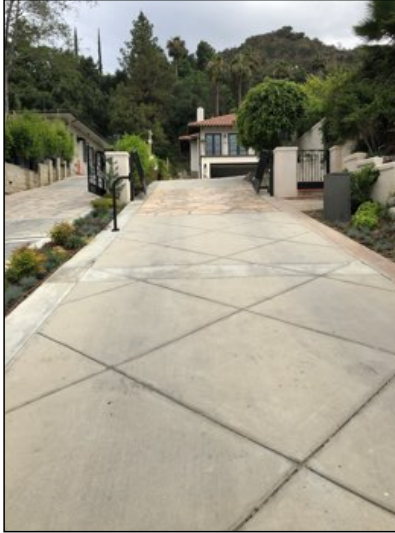
Driveway had common cracks \*, Appears serviceable.

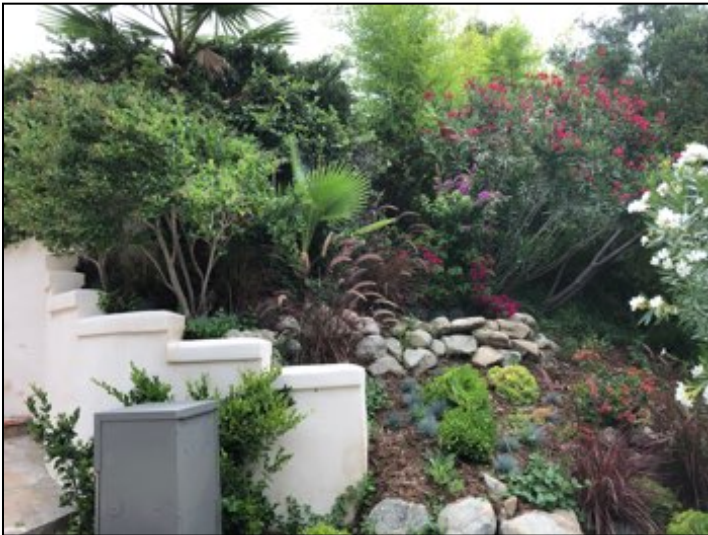
Retaining walls located on: South side is masonry block wall, appears serviceable.

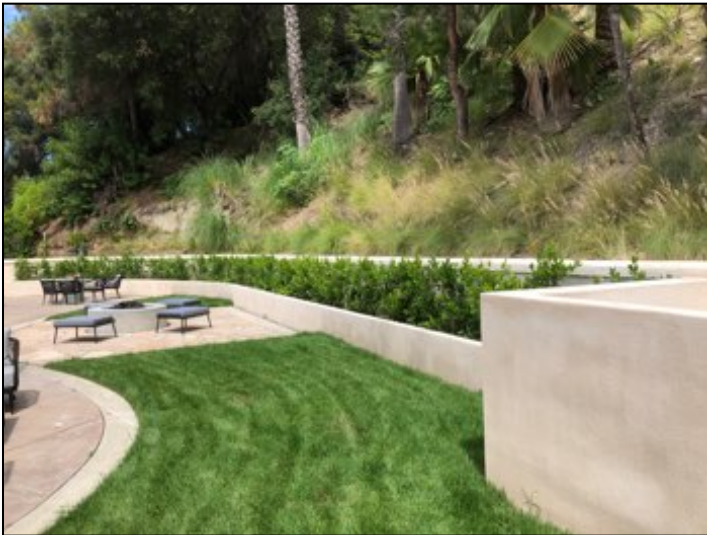
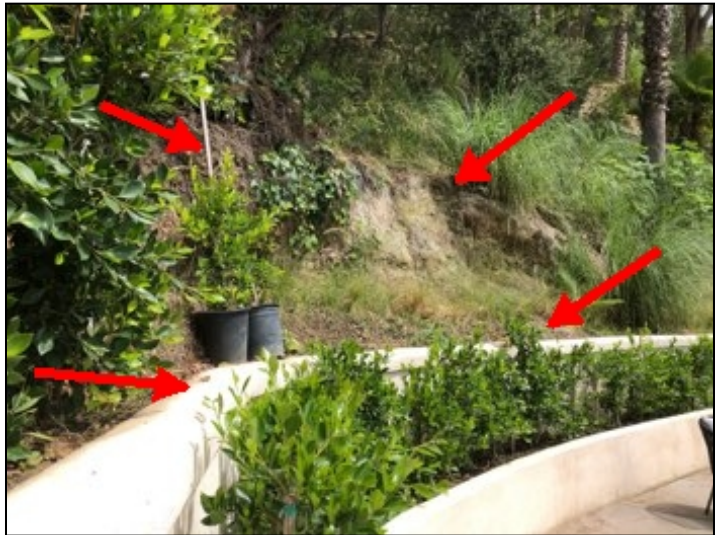
Retaining walls located on: North side is masonry block wall, appears serviceable.

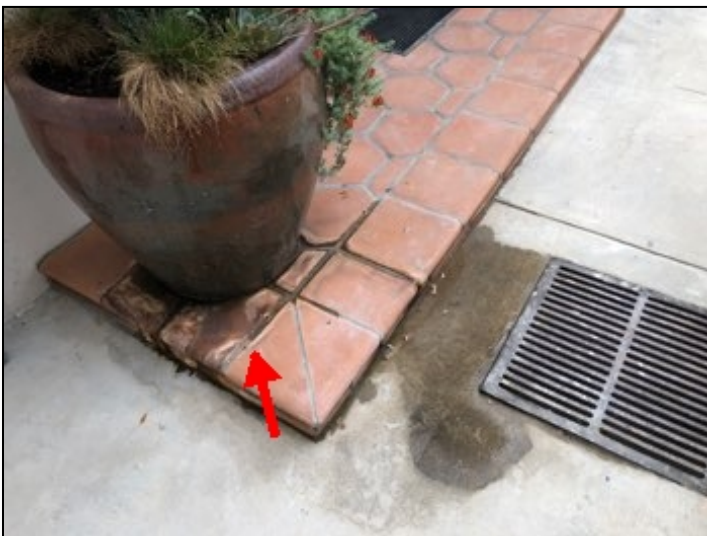
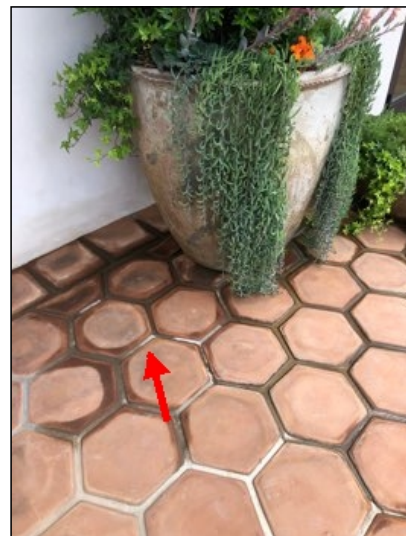
Planter Pots installed at south side front, west side, and rear of property are leaking water onto patio floor causing stains and algae growth \*. Recommend repair.

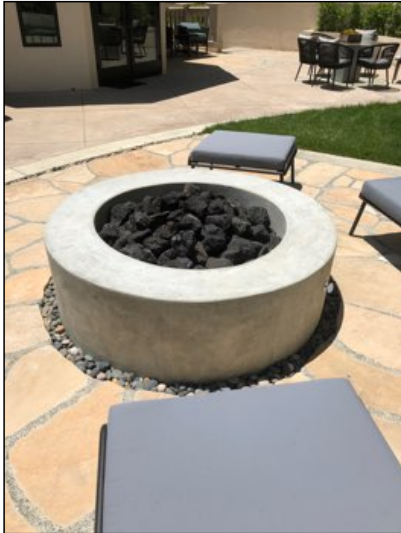
Gas fire pit located at front yard and rear yard installed, appears serviceable.

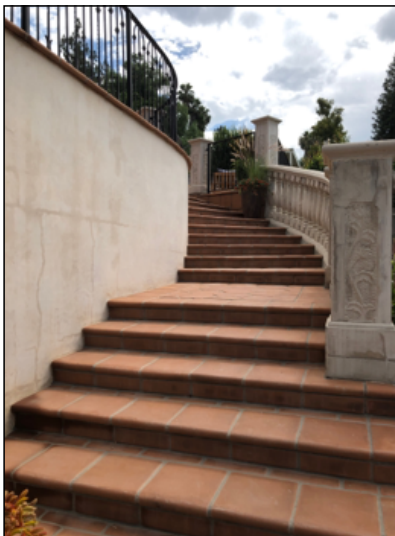
Front entrance railing not installed a base of stairs located at front \*(4), recommend installing as required.

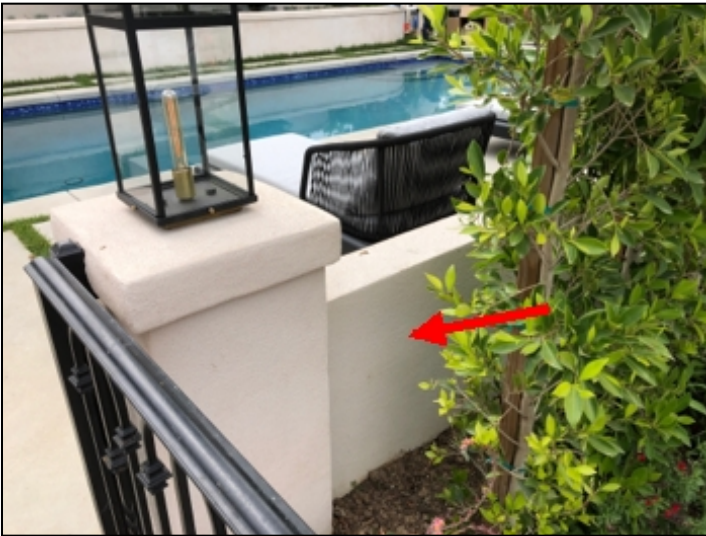
Masonry block wall located at front for pool area appears to be too short allowing small child to climb over (4), safety hazard. Recommend repair as required.

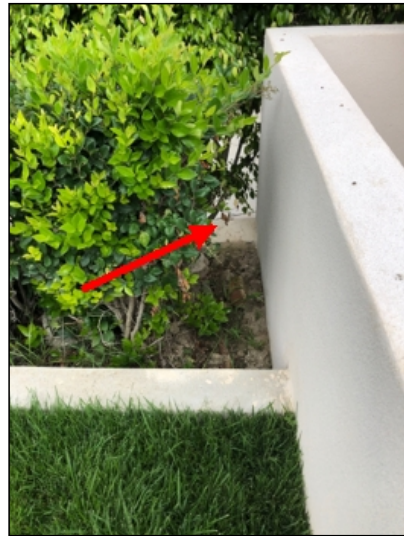
Front patio/lawn area does not have a railing installed (4), safety hazard. Small child may fall. Recommend repair as a safety upgrade.

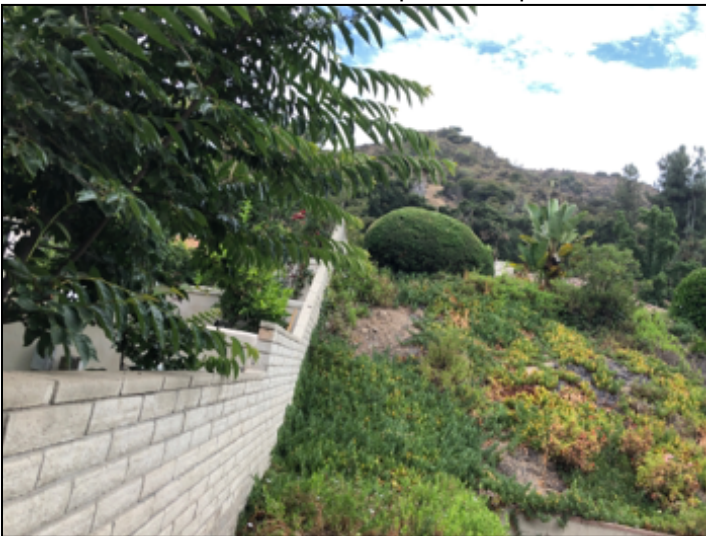
Fence at property is masonry block located on east side.

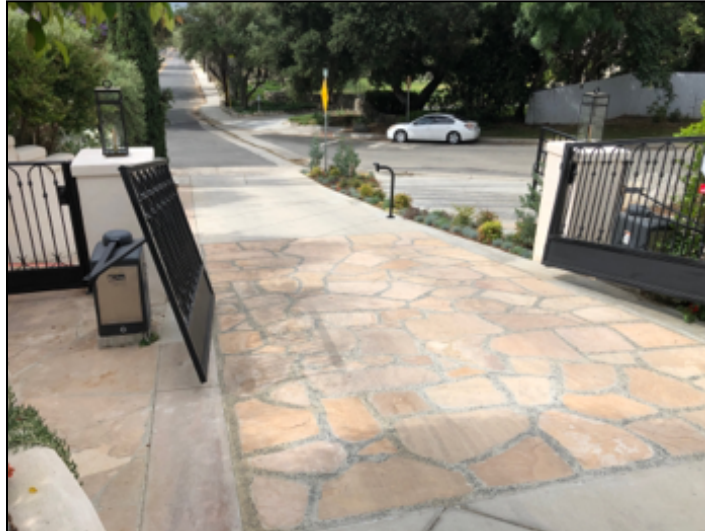
Automatic driveway gate installed does not appear to have a reversing sensors installed as required (4), recommend installing as required by current safety standards.

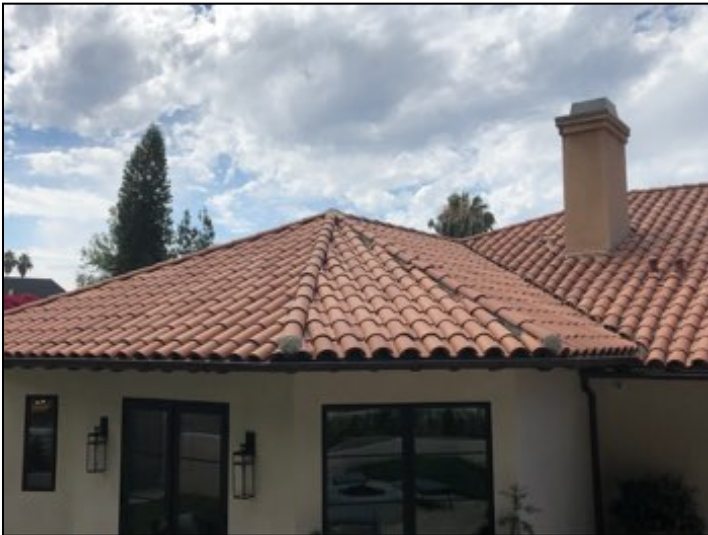
Main roof is clay tile, the majority of roof appears serviceable with few broken tiles. Recommend having broken roof tiles repaired as required to prevent moisture intrusion.

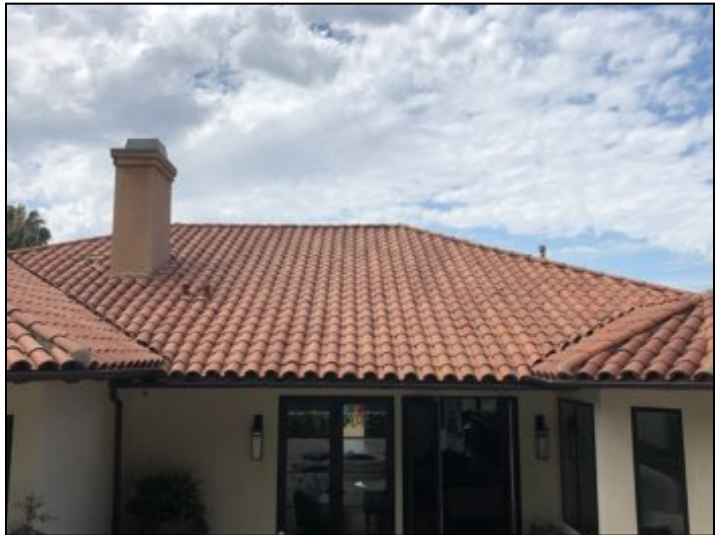
Main roof is clay tile, the majority of roof appears serviceable with few broken tiles. Recommend having broken roof tiles repaired as required to prevent moisture intrusion.

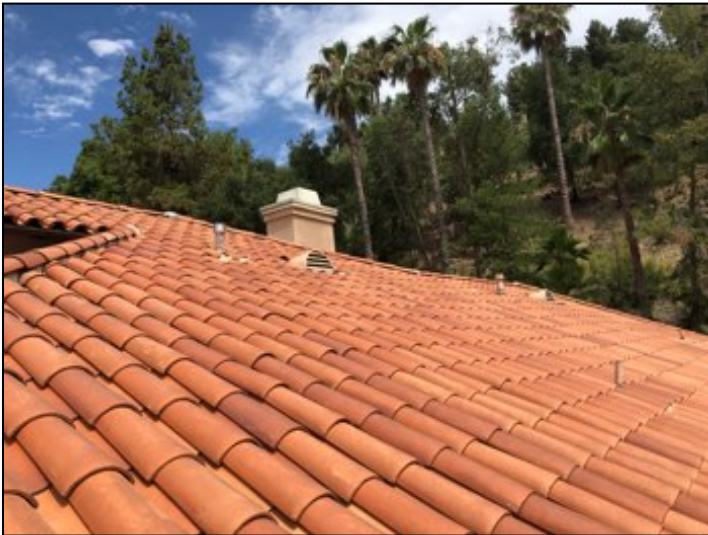
Main roof is clay tile, the majority of roof appears serviceable with few broken tiles. Recommend having broken roof tiles repaired as required to prevent moisture intrusion.

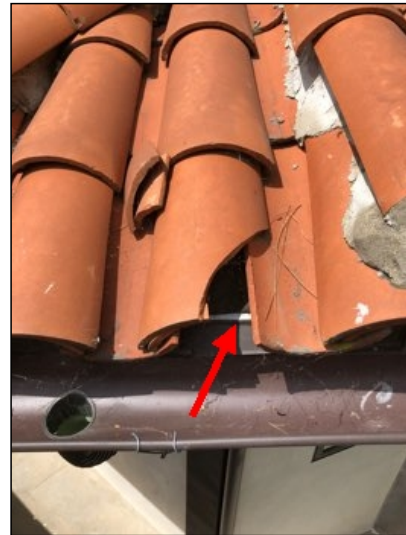
Roof clay tile is broken located on NE corner (2), recommend repair to prevent moisture intrusion.

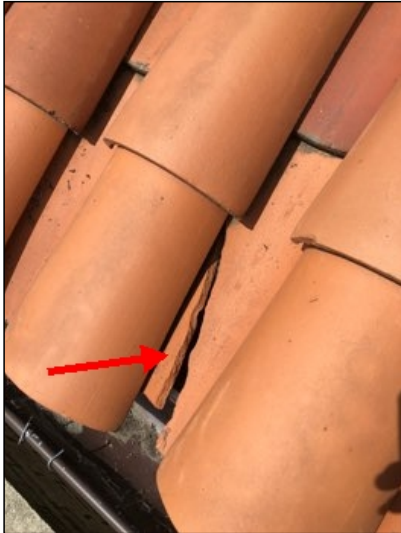
Roof clay tile is broken located on east side (2), recommend repair to prevent moisture intrusion.

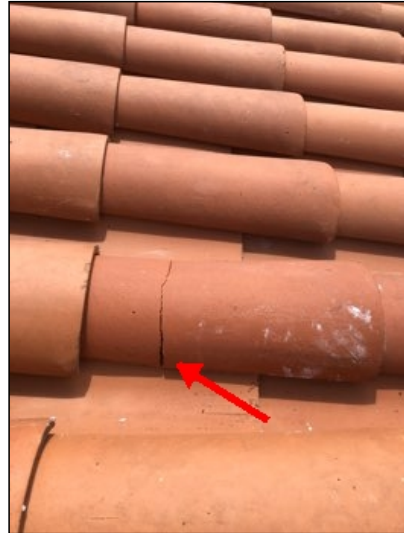
Broken clay tile at third floor visible from second floor balcony (2), recommend repair.

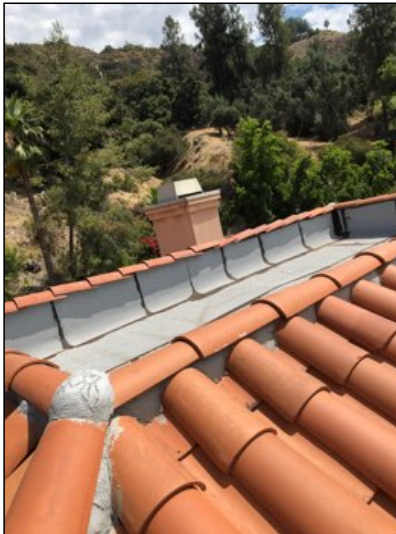
Middle section of property has a low slope flat roof, inspector did not have access to flat roof area. Inspection is limited \*.

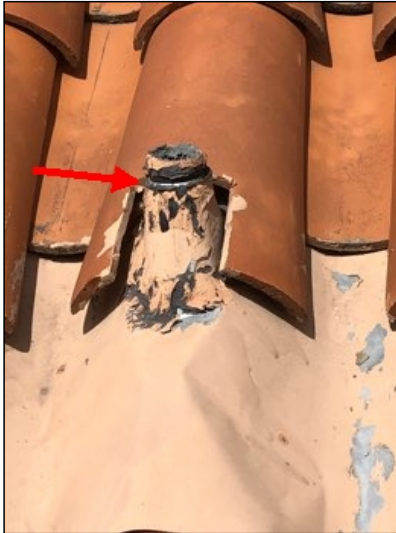
Vent flashing located on rear east side has a damaged roofing mastic and vent flue is too short \*, recommend repair.

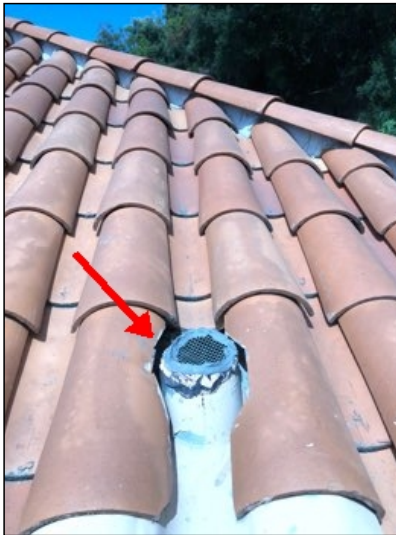
NE corner vent is missing pipe which may allow water to enter into wood framing (3)(2), recommend repair. Water intrusion will cause moisture damage to wood framing.

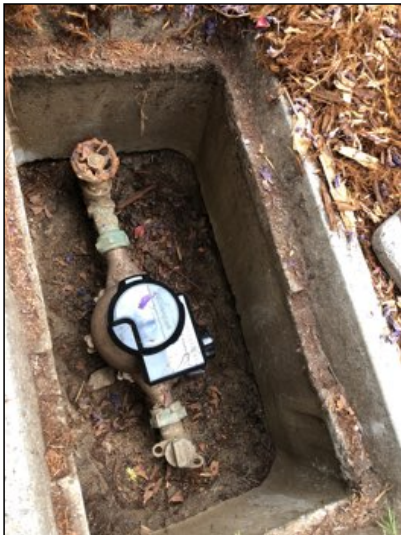
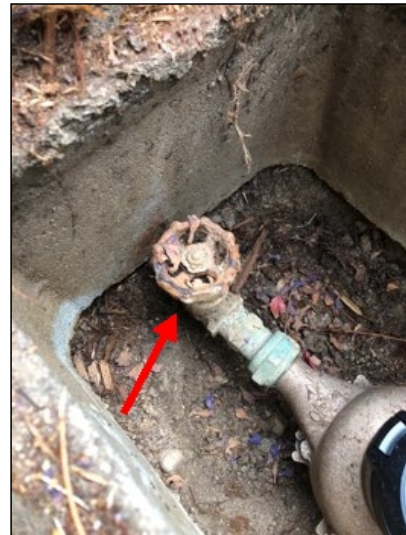
(1" Cooper main/property side) Main water supply pipe at meter and at property side is 1" copper, main water shut off at meter and property side appears serviceable. Under ground pipes can are considered not inspected.

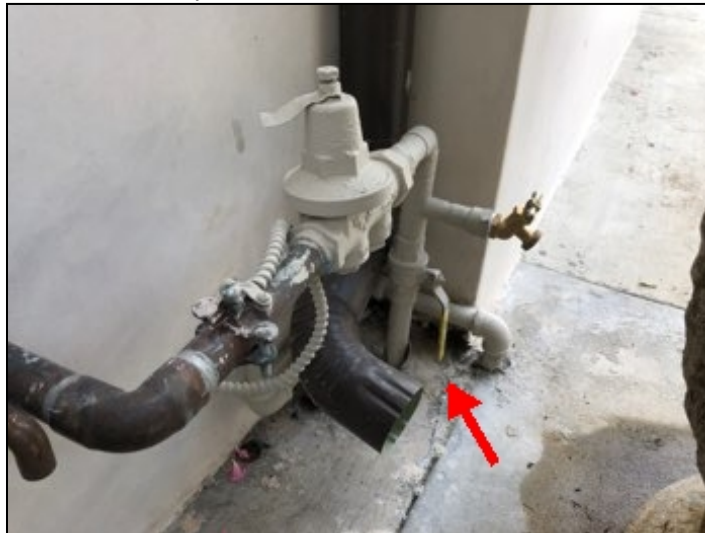
(west) Main water shut off valve installed located on west side of property, valve appears serviceable.

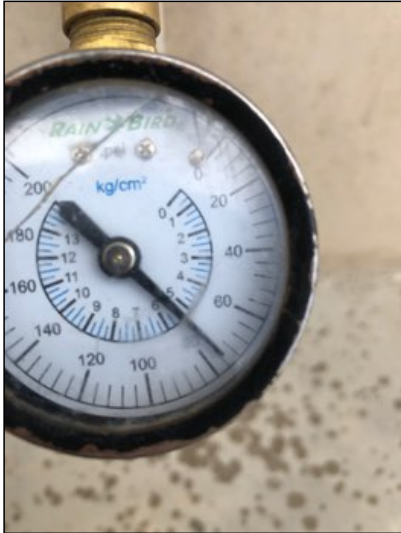
Main water supply pipe pressure is 75 psi., appears serviceable.

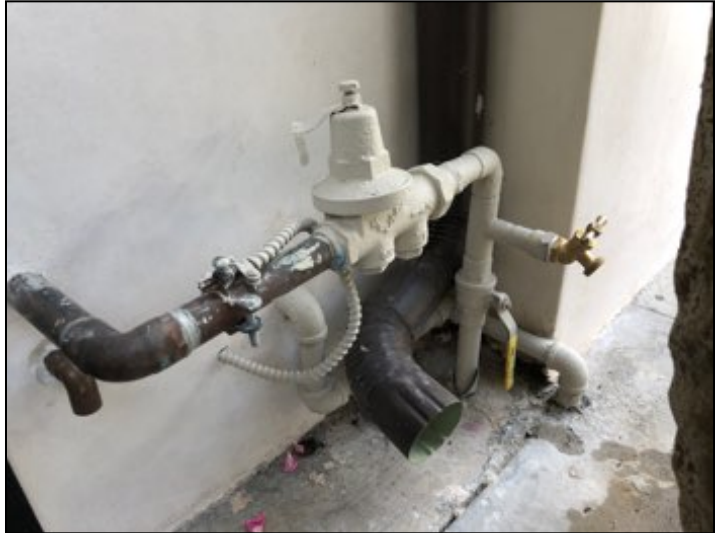
(no pressure exhaust) Main water supply pipe does not have a pressure exhaust installed as required (2), recommend installing. Recommend further review and repair by licensed plumber.

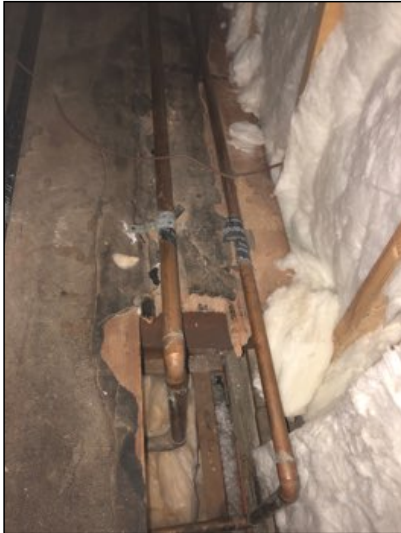
Water supply pipes that are visible are copper, appears serviceable. See notes below for other issues that may be present.

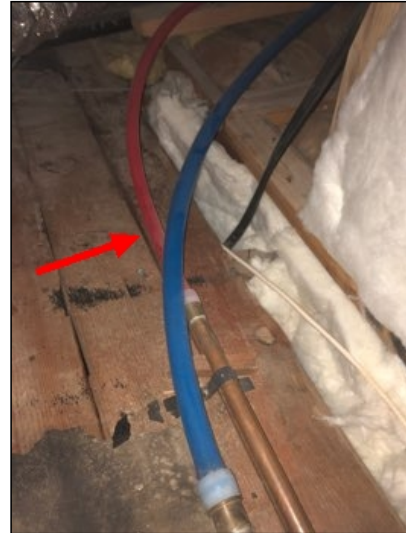
Water supply pipes are PEX (Crosslinked Polyethylene). Some name brands such as Aquapex, Zurn, and Kitec have been associated with class action law suits. Failures from pipes included: Leaching of chemicals into potable water, Pipe fitting premature corrosion causing leaks, as well as other documented issues. The brand name installed at property does not appear to be associated with failures but does not guarantee no issue or failures will ever occur with PEX piping. Inspection is limited.

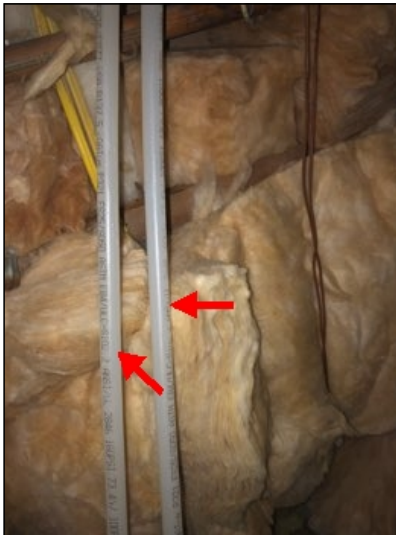
Water supply pipes are PEX (Crosslinked Polyethylene). Some name brands such as Aquapex, Zurn, and Kitec have been associated with class action law suits. Failures from pipes included: Leaching of chemicals into potable water, Pipe fitting premature corrosion causing leaks, as well as other documented issues. The brand name installed at property does not appear to be associated with failures but does not guarantee no issue or failures will ever occur with PEX piping. Inspection is limited.

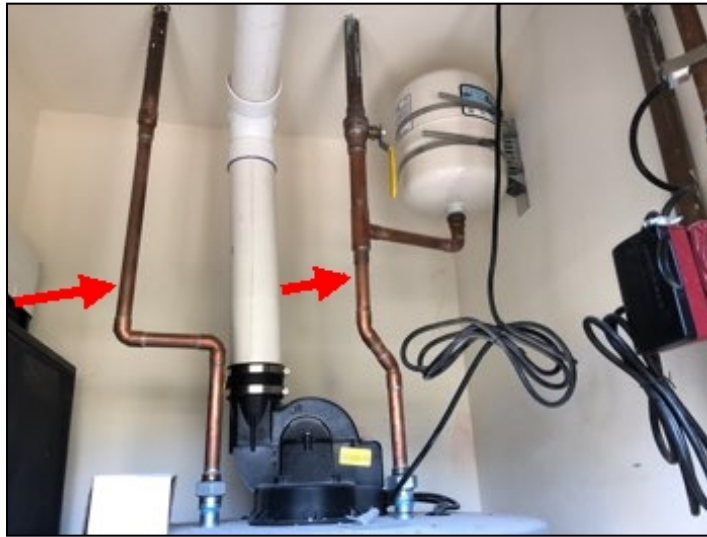
(rigid pipe) Water supply pipes to water heater do not have flexible water supply as required by current seismic water heater standards (2), recommend further review and repair of water supply pipes. Water supply pipes should have flexible water supply pipes to with stand damage from earth quake.

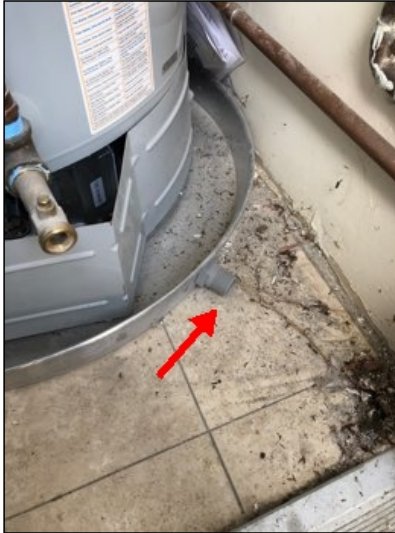
Water heater catch pan does not have a drain pipe that routes to exterior (2), recommend installing a proper drain as required to properly drain in case of possible leak (2).

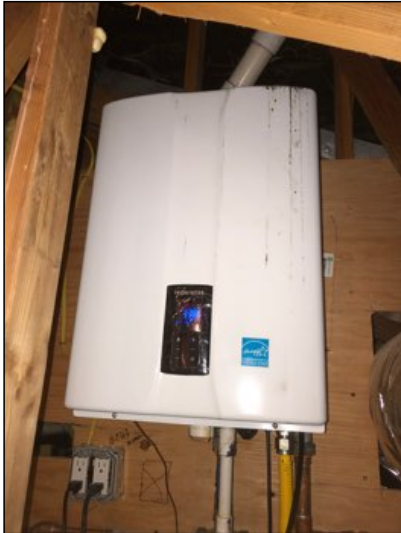
Tankless water heater installed, appears serviceable, see notes below for other issues that may be associated with Tankless water heater.

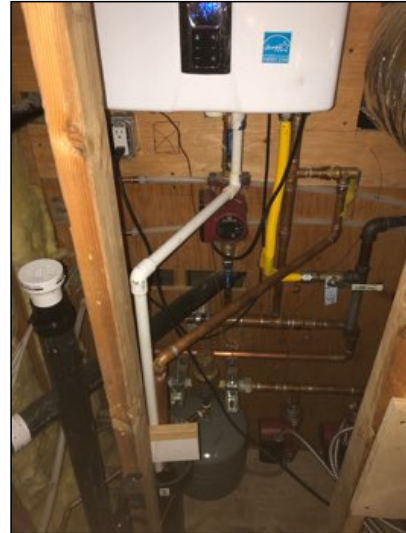
Tankless water heater located in attic does not have a water catch pan installed that will catch water in case of leak \*, recommend installing as an upgrade.

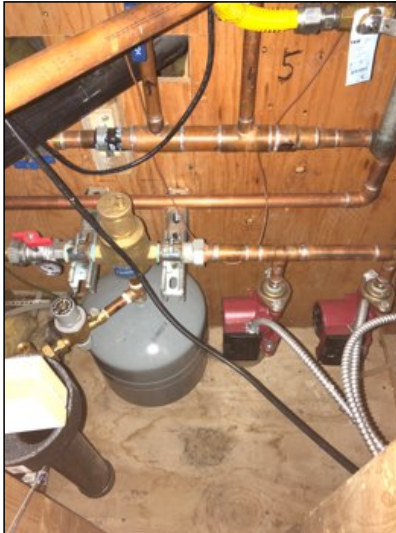
Tankless water heater plumbing appears serviceable.

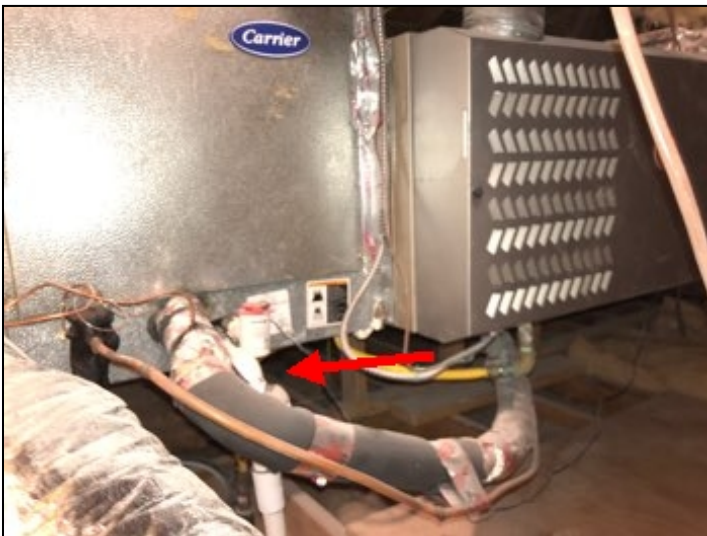
Cooling coil at furnace located in attic did not have a secondary catch pan installed, recommend installing catch pan to catch condensation from cooling coil as required \*. Secondary catch pans are recommended to insure excess condensation does not cause moisture damage. Secondary catch pans required at all HVAC unit in attic.

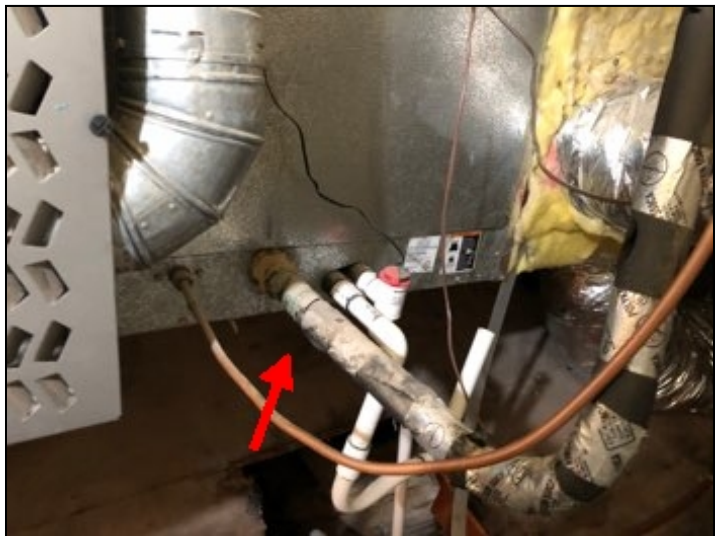
Cooling coil at furnace located in attic did not have a secondary catch pan installed, recommend installing catch pan to catch condensation from cooling coil as required \*. Secondary catch pans are recommended to insure excess condensation does not cause moisture damage. Secondary catch pans required at all HVAC unit in attic.

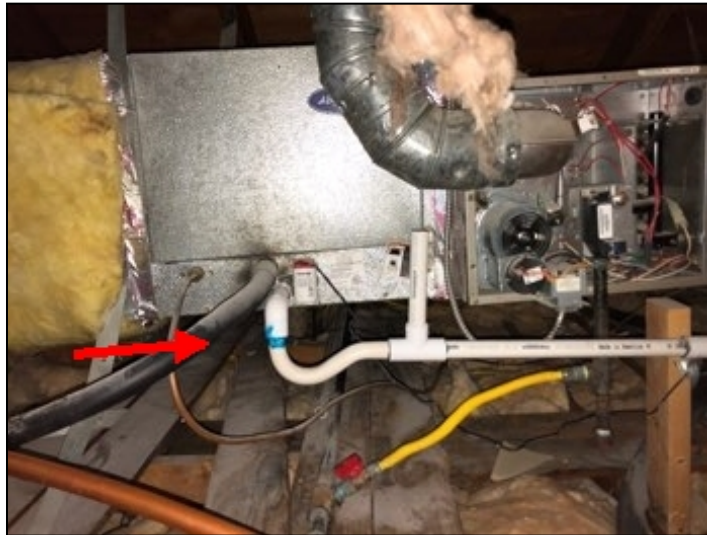
Cooling coil at furnace located in attic did not have a secondary catch pan installed, recommend installing catch pan to catch condensation from cooling coil as required \*. Secondary catch pans are recommended to insure excess condensation does not cause moisture damage. Secondary catch pans required at all HVAC unit in attic.

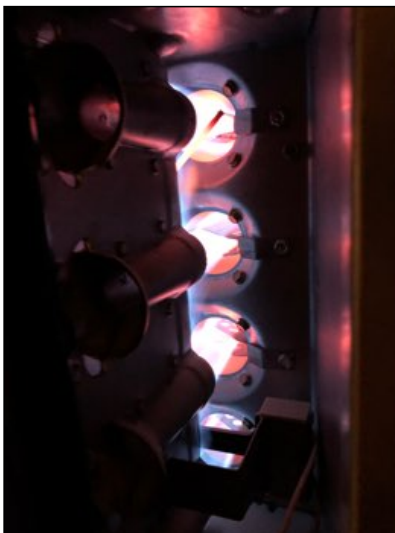
Furnace burner flame appears typical.

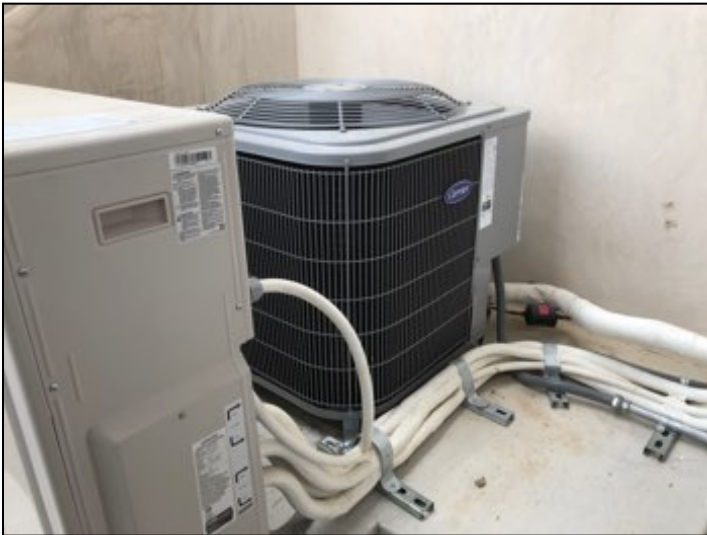
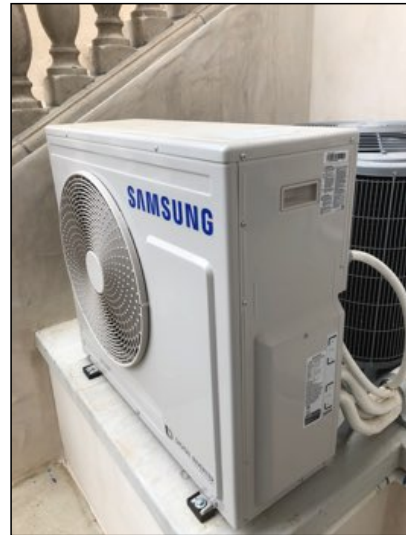
HVAC compressor unit (A) located at exterior west side. Unit (A) compressor services first floor kitchen and living area. HVAC unit (B) located on exterior west side is a heat pump. Services first floor living area off of garage.

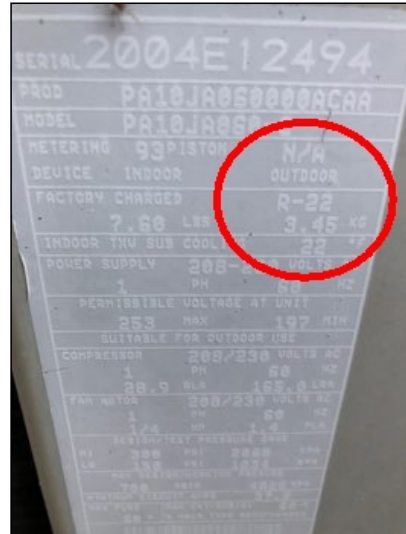
HVAC compressor unit (C) installed at property is charged with HCFC-22 or R-22 Freon refrigerant. HCFC-22 and R-22 will become banned in the year 2020. EPA states that you can continue to use your system that contains HCFC-22 Freon after 2020. The issue is if you need HVAC service after 2020. The HVAC service may be more costly and or may not be able to find refrigerant. Only options is do nothing and use HVAC system till it needs service and repair, retro-fit system to be allowed other refrigerant, and or replace system preemptively. Disclaimer \*.

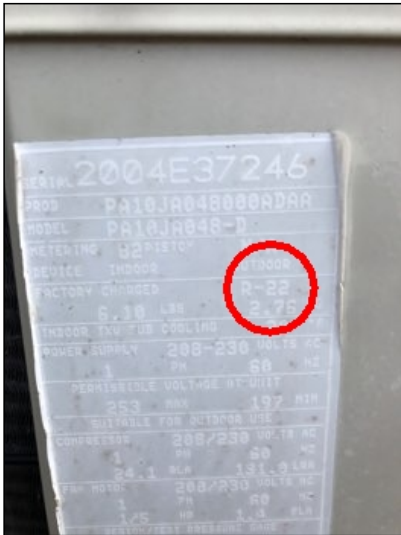
HVAC compressor unit (D) installed at property is charged with HCFC-22 or R-22 Freon refrigerant. HCFC-22 and R-22 will become banned in the year 2020. EPA states that you can continue to use your system that contains HCFC-22 Freon after 2020. The issue is if you need HVAC service after 2020. The HVAC service may be more costly and or may not be able to find refrigerant. Only options is do nothing and use HVAC system till it needs service and repair, retro-fit system to be allowed other refrigerant, and or replace system preemptively. Disclaimer \*.

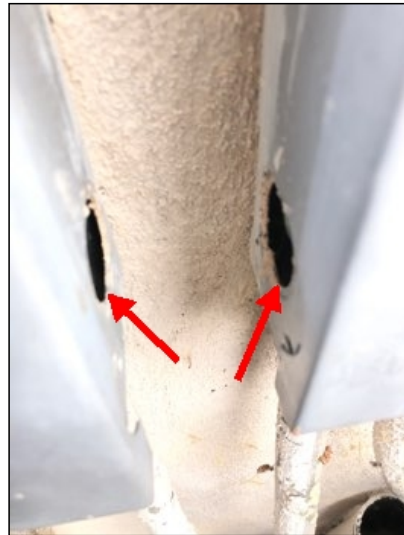
HVAC electrical shut off breaker has exposed knock outs (4), safety hazard. Recommend repair. Electrical shut off is for rear compressors.

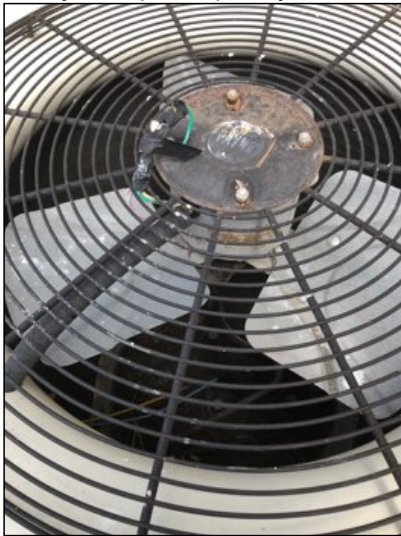
HVAC compressor units (C) and unit (D) is worn and appears to be nearing/or at the end of its normal useful life (2). Older HVAC units are not as efficient as newer HVAC units, consider installing newer HVAC unit for better efficiency.

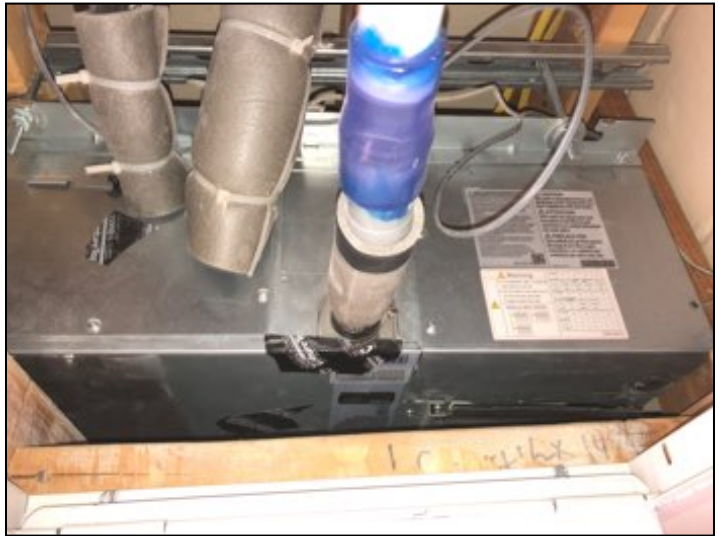
Heat pump for unit (B) for lower level guest house area located at bedroom closet.

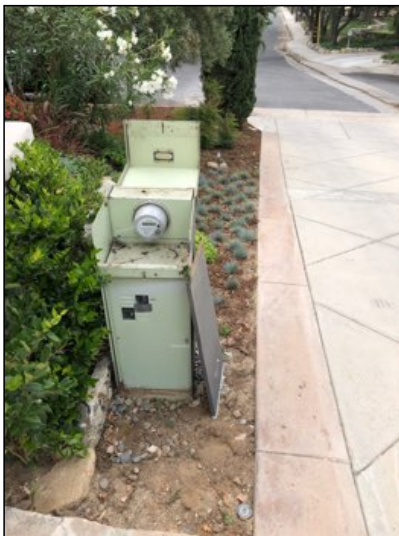
Main electrical panel breaker/meter located at driveway.

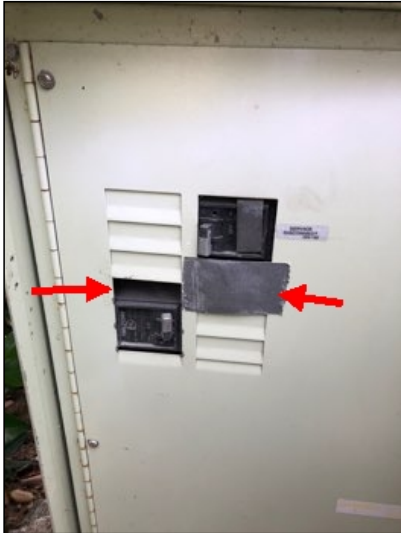
Main electrical panel has exposed knock outs at missing breakers (4), safety hazard recommend repair. Improper tape was installed to cover exposed knock outs.

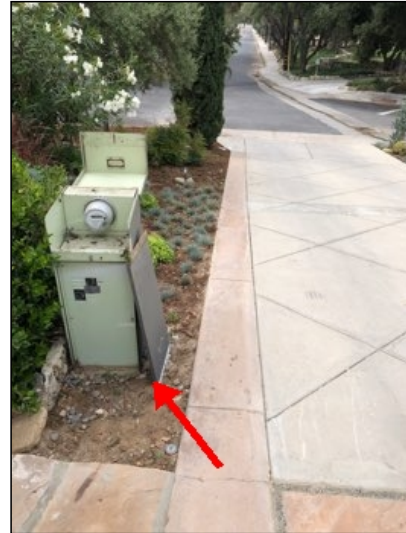
Main electrical panel container located at driveway does not have a protective bollard to prevent damage from a automobile strike \*, recommend installing as an upgrade.

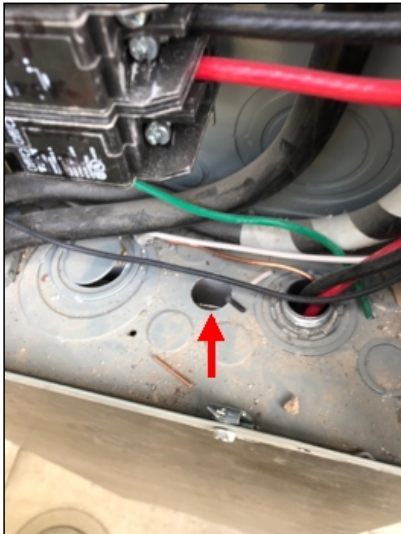
Exposed knock at base of the electrical panel (4), safety hazard recommend repair.

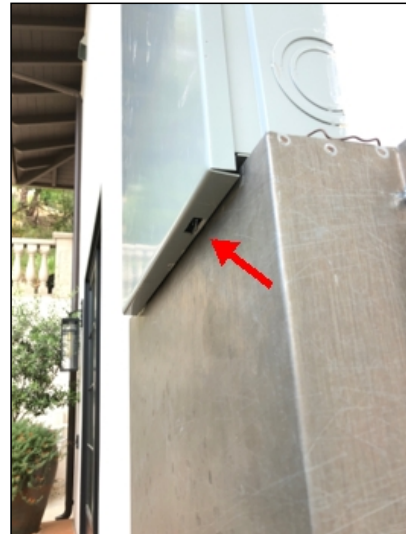
Main electrical panel cover does not latch properly due to metal panel directly underneath \*, recommend repair.

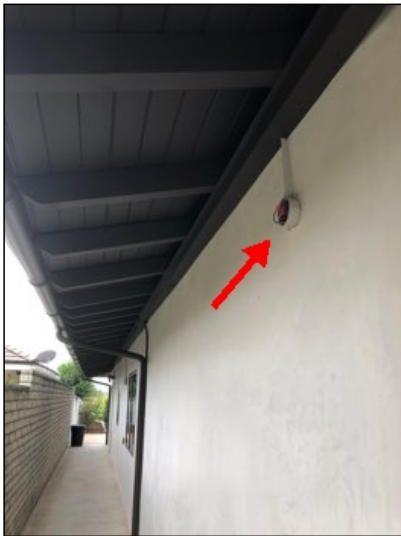
Exterior west side light fixture is missing with exposed live electrical conductors (4)(2), safety hazard. Recommend further review and repair by licensed contractor.

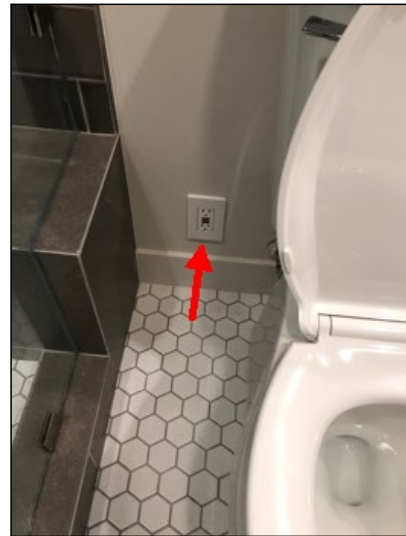
Bathroom (E) GFCI electrical outlet did not reset when tested \*, inspector could not locate other GFCI that will reset and or outlet is miss wired \*.

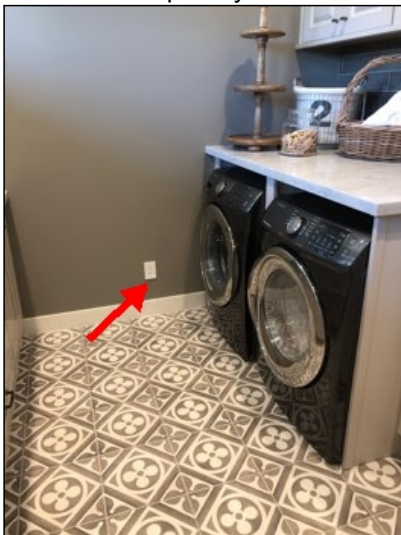
Electrical outlet at laundry room main floor north wall is non functional (2), Recommend further review and repair by licensed contractor.

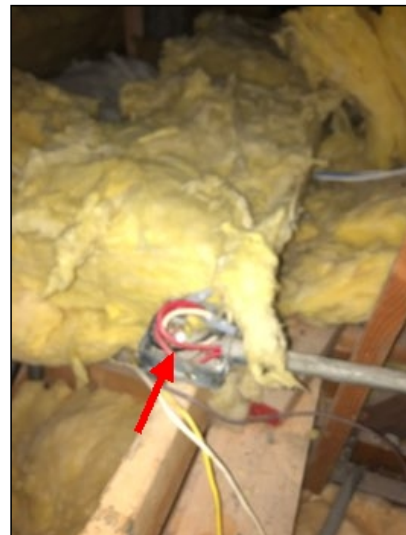
Various electrical junction boxes in attic space did not have covers installed \*(4), recommend installing cover as a safety upgrade \*.

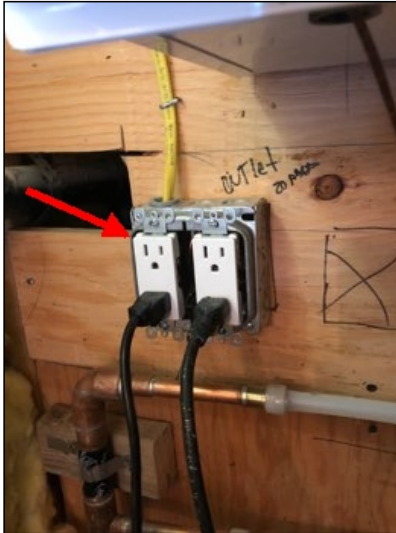
Various attic electrical light switches are missing cover plates \*(4), recommend installing as required.

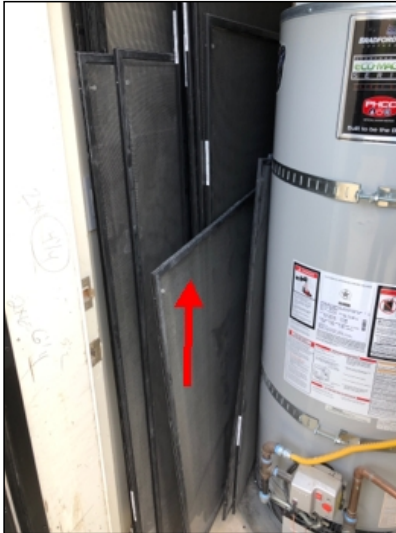
Property screens stored in water heater closet

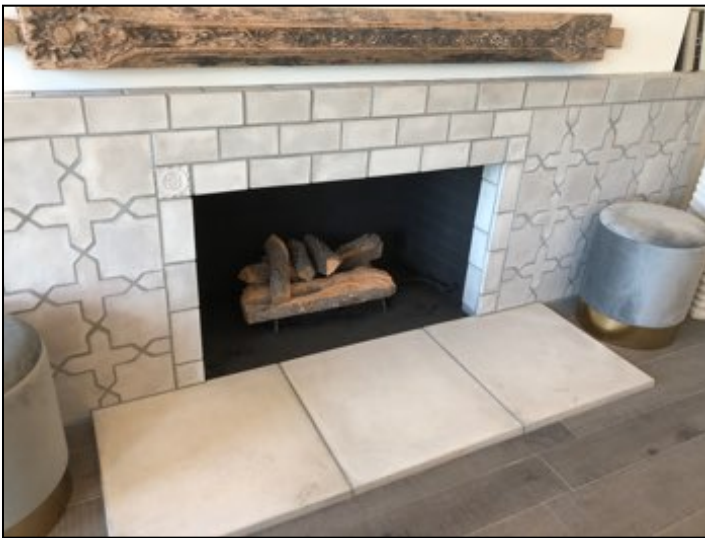
Fire place (A) located at family room.

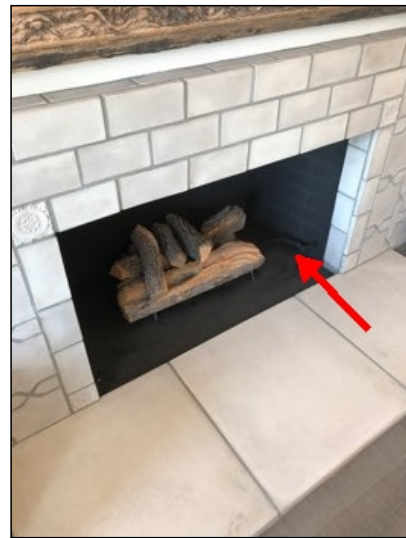
Fireplace does not have a spark screen installed as required (4), safety hazard.

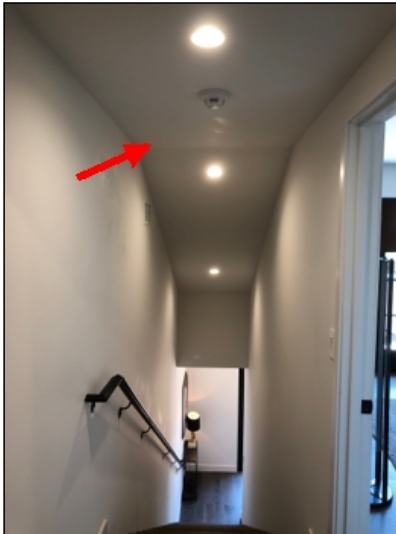
Smoke detectors not installed at main hallway leading into bedrooms at third floor as require by current standards (4)(5), safety hazard. Recommend installing functioning smoke detector(s) at all main hallways that lead into a bedroom.

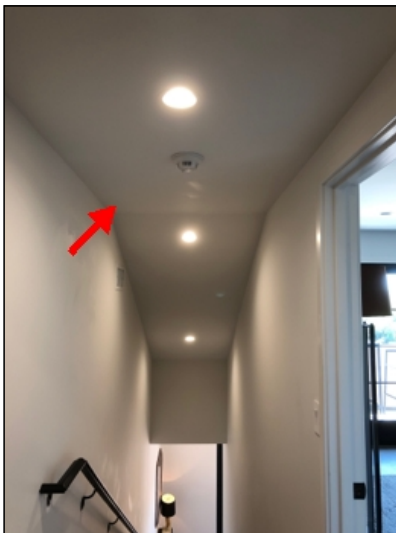
Carbon monoxide alarm was NOT installed at third floor main hallway leading into bedrooms as required by California law (4)(5), safety hazard. Recommend installing functioning carbon monoxide alarms at second floor hallways that lead into bedrooms.

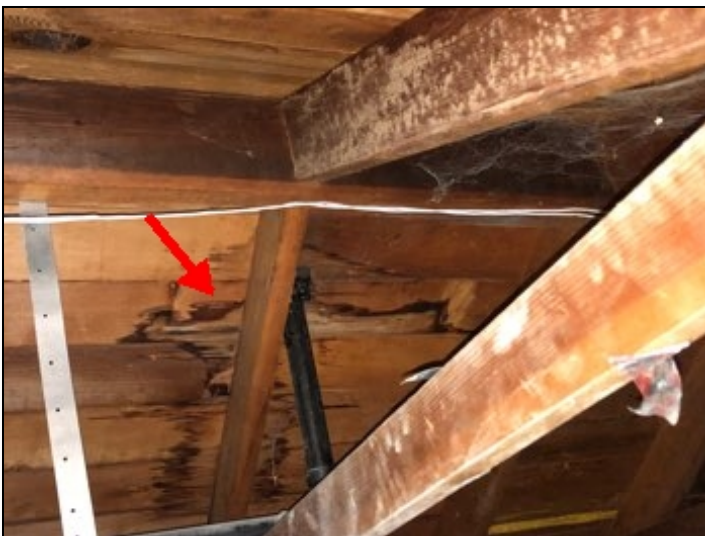
Moisture stains visible in attic space roof framing at various areas \*, inspector could not determine if leaks are active \*, inspection is limited (2). Recommend having all roof tiles that are broken and flashing mentioned on roofing section repaired along with having a licensed roofing contractor further review roof.

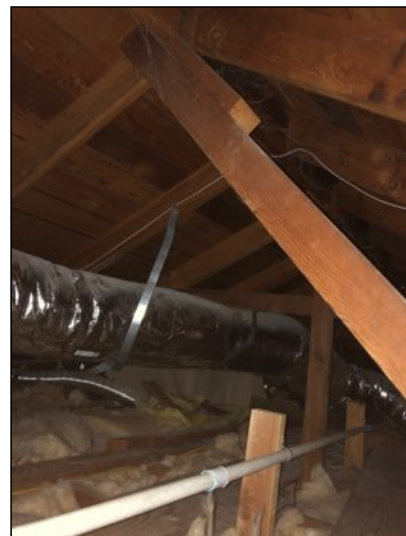
Attic structure is conventional wood framing 2x6 ceiling joist and 2x6 roof rafters, plywood roof.

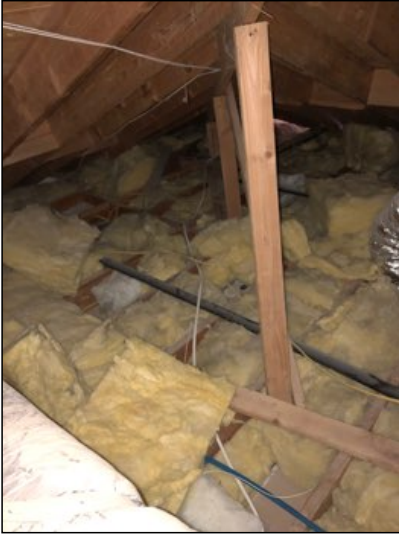
Insulation is fiberglass batts, approx 8" depth.

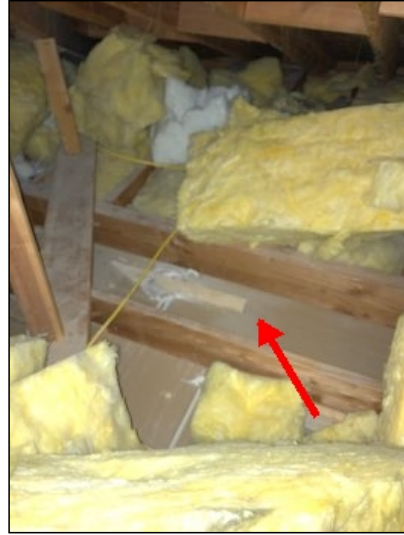
Few areas in main attic has missing/displaced insulation \*. Recommend repair.

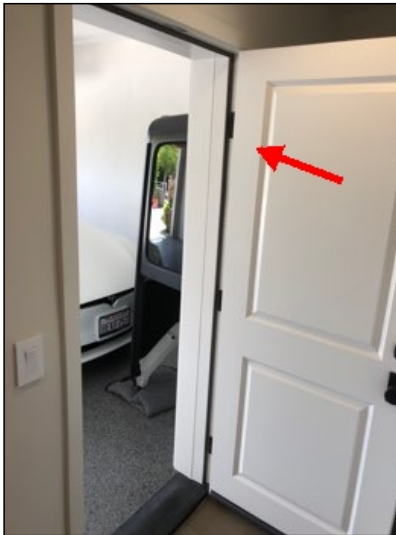
Garage door to the interior does not have self closing, self latching mechanism installed as required by current standards (5). Recommend installing safety closing mechanism as required by current standards.

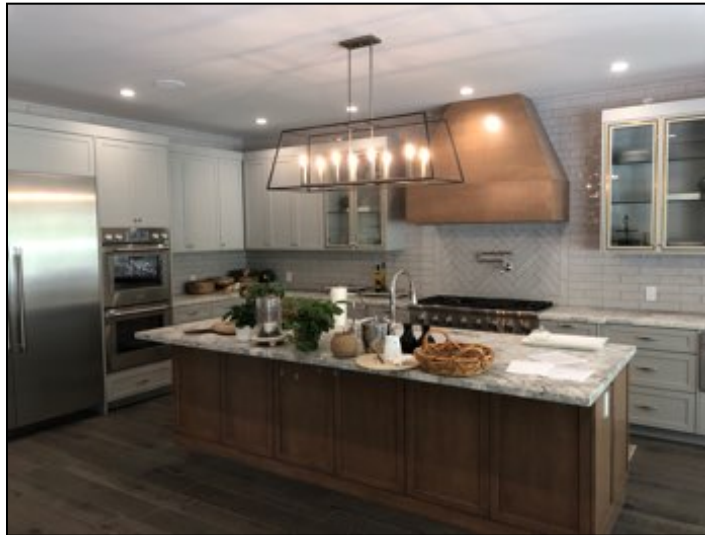
Kitchen Counters, cabinets, floor and lights appear in serviceable condition.

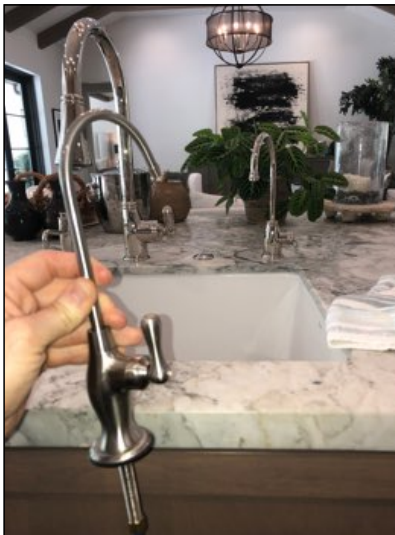
Kitchen sink plumbing has a reverse osmosis filter installed. The supply faucet is loose under kitchen sink and faucet attached to kitchen sink is non functional \*. Recommend repair.

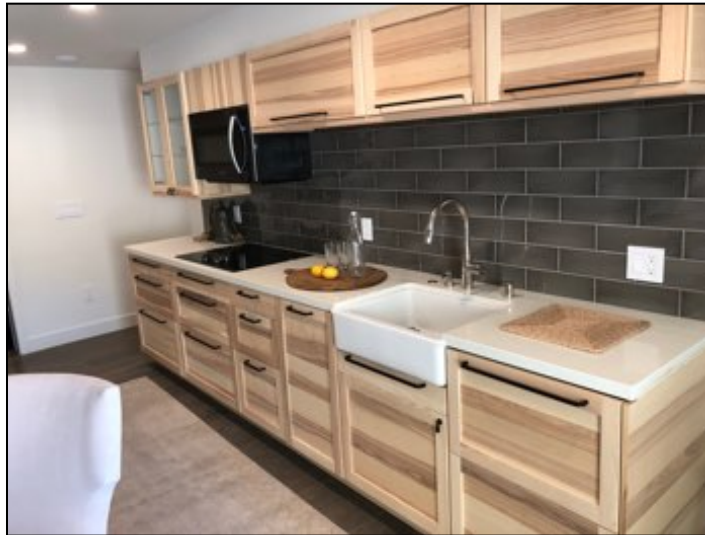
Kitchen Counters, cabinets, floor and lights appear in serviceable condition.

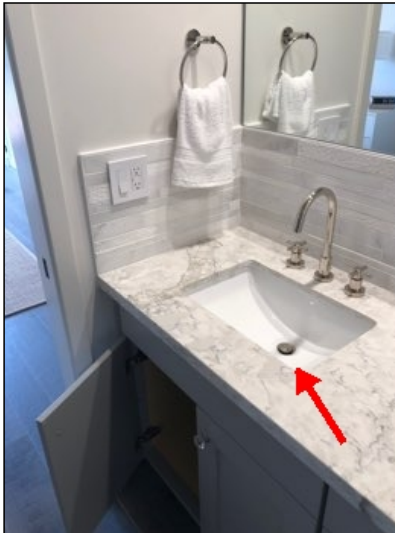
Bathroom (B) left side sink had gargling noise at drain (2), Recommend further review and repair by licensed contractor.

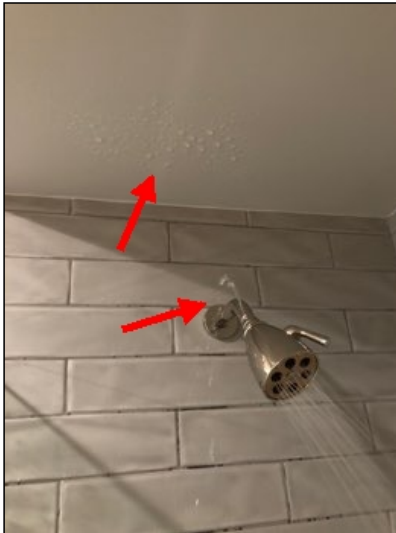
Bathroom (C) shower head is loose and leaks hitting ceiling when shower is turned on \*, recommend repair.

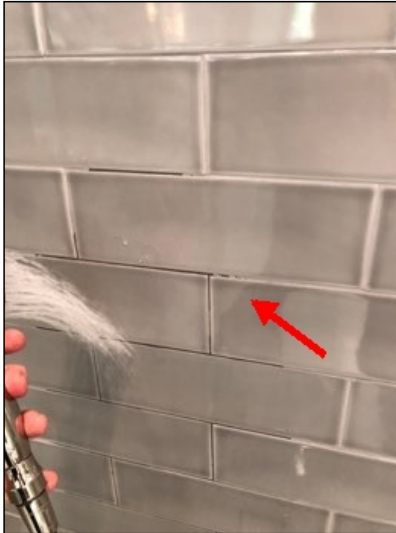
Bathroom shower grout tile enclosure was not sealed as required when stone tile is used \*. Shower grout sealer is installed to prevent water from wicking into tile and to prevent dark stain/mold growth. Grout sealer will extend the life of shower enclosure and should always be installed to natural stone tile because natural stone is so porous. Located at all shower enclosures. Recommend repair.

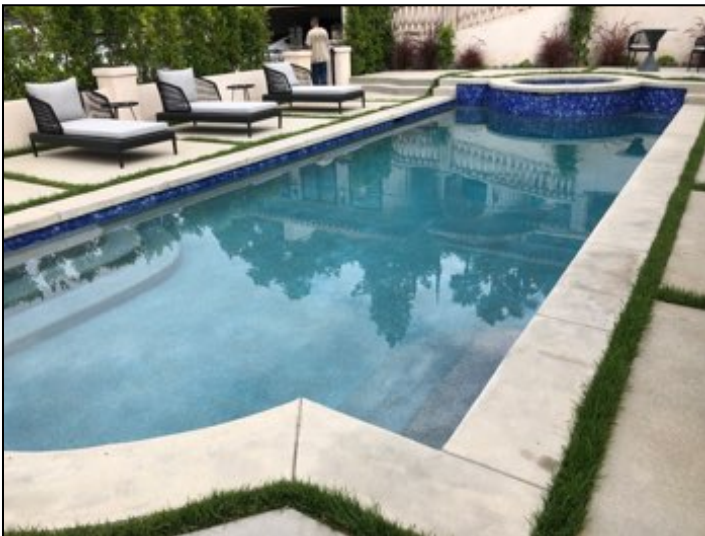
Pool plaster/plaster gunite appears serviceable.

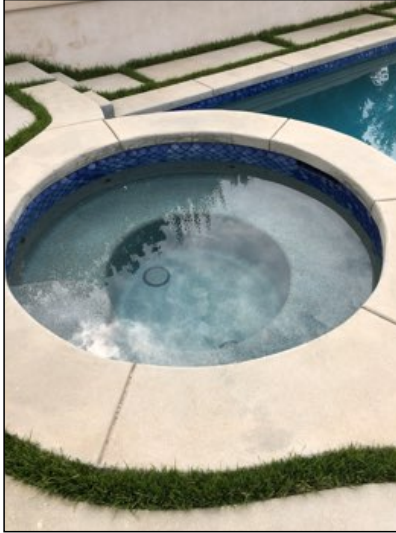
Below ground, plaster attached to pool, two anti-vortex drains installed. Appears serviceable.
