# Guardian Home Inspection Property Inspection Report

123 Southern California , Sample Report , Ca. 90000

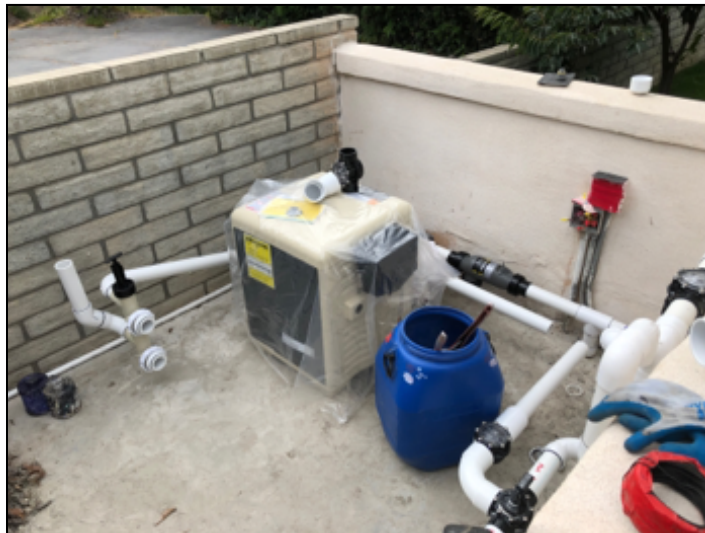
N/A Pool equipment was being upgraded/replaced at the time of the inspection. Pool and jacuzzi was not tested.

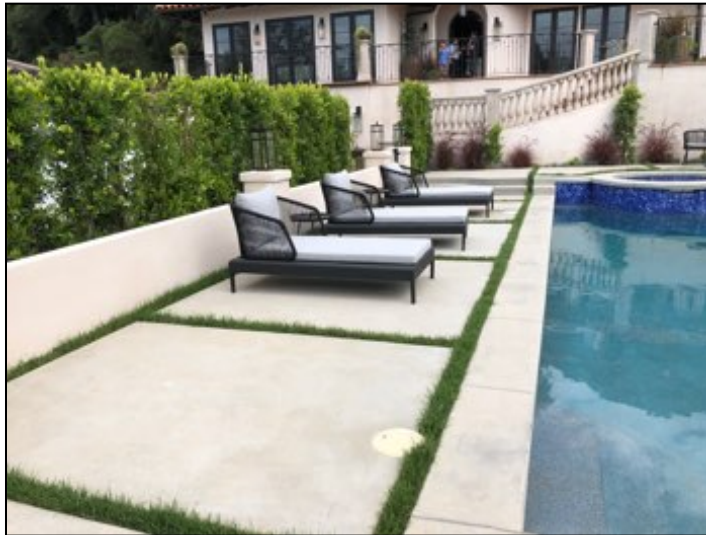
Appears in satisfactory and functional condition with normal wear for its age. Appears to be sound structure.
