15-Passenger Van Safety Review

PAIRED SIDE IMPACT CRASH TESTING of a 15 PASSENGER VAN & an MFAB

INTERNAL RESEARCH REPORT ASFB 11- 05

October 5, 2012

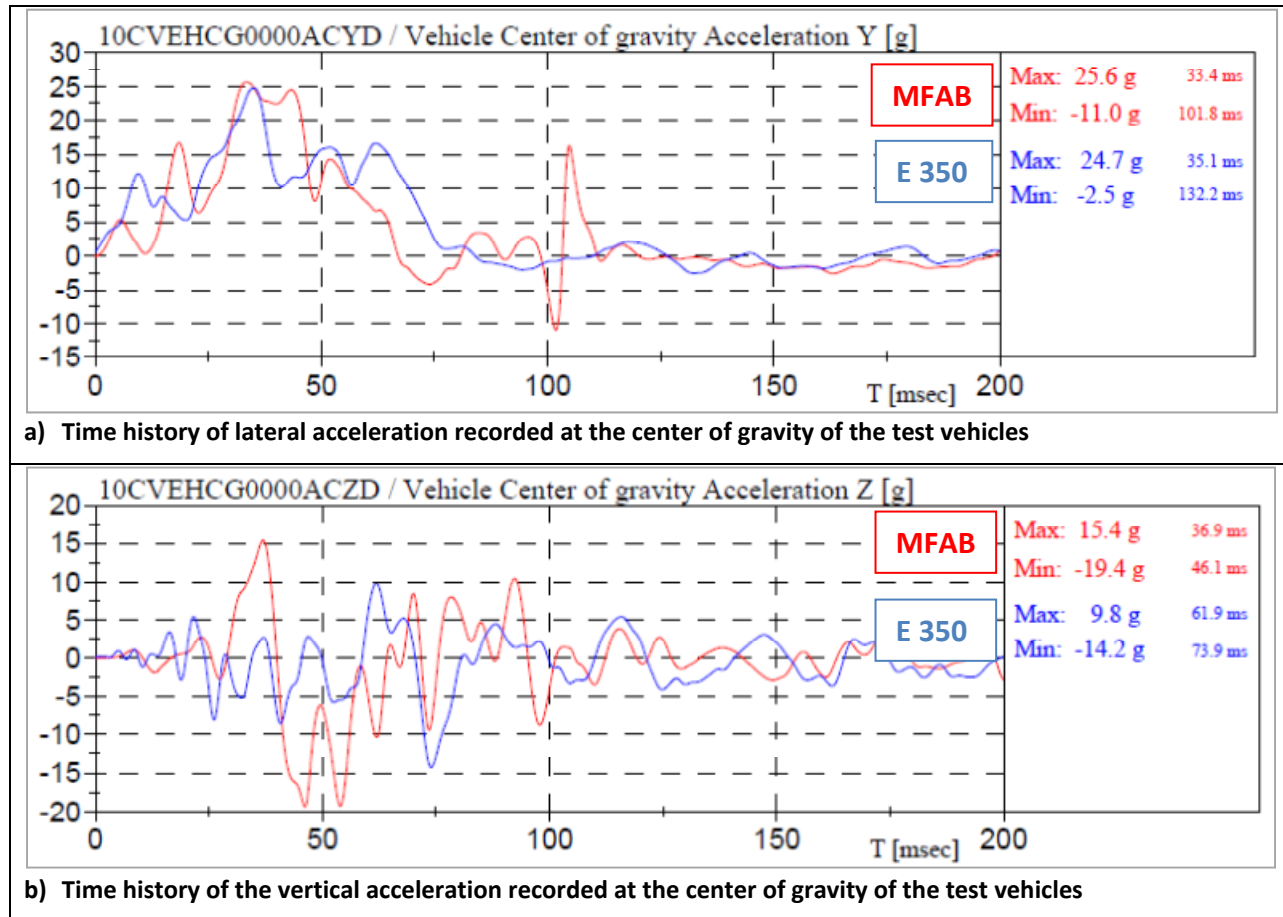
Figure 7. Time history traces of the accelerations recorded in each test vehicle.

The accelerometers mounted to the center of gravity of each test vehicle recorded similar peak lateral accelerations. The top graph shown in Figure 7a shows that the peak lateral acceleration for the E350 shown in blue was 24.7 g occurring at 35.1 ms while the peak lateral acceleration for the MFAB, shown in red was 25.6 g occurring at 33.4 ms. Both acceleration traces indicate very rapid onsets of lateral acceleration with the peaks occurring within the first 35 ms of the impact. The MFAB appears to have experienced a longer sustained lateral acceleration than the E350. Figure 7b illustrates the vertical component of the acceleration recorded at the center of gravity of the test vehicles. The MFAB shown by the red trace appears to have experienced slightly greater vertical impulse than the E350.

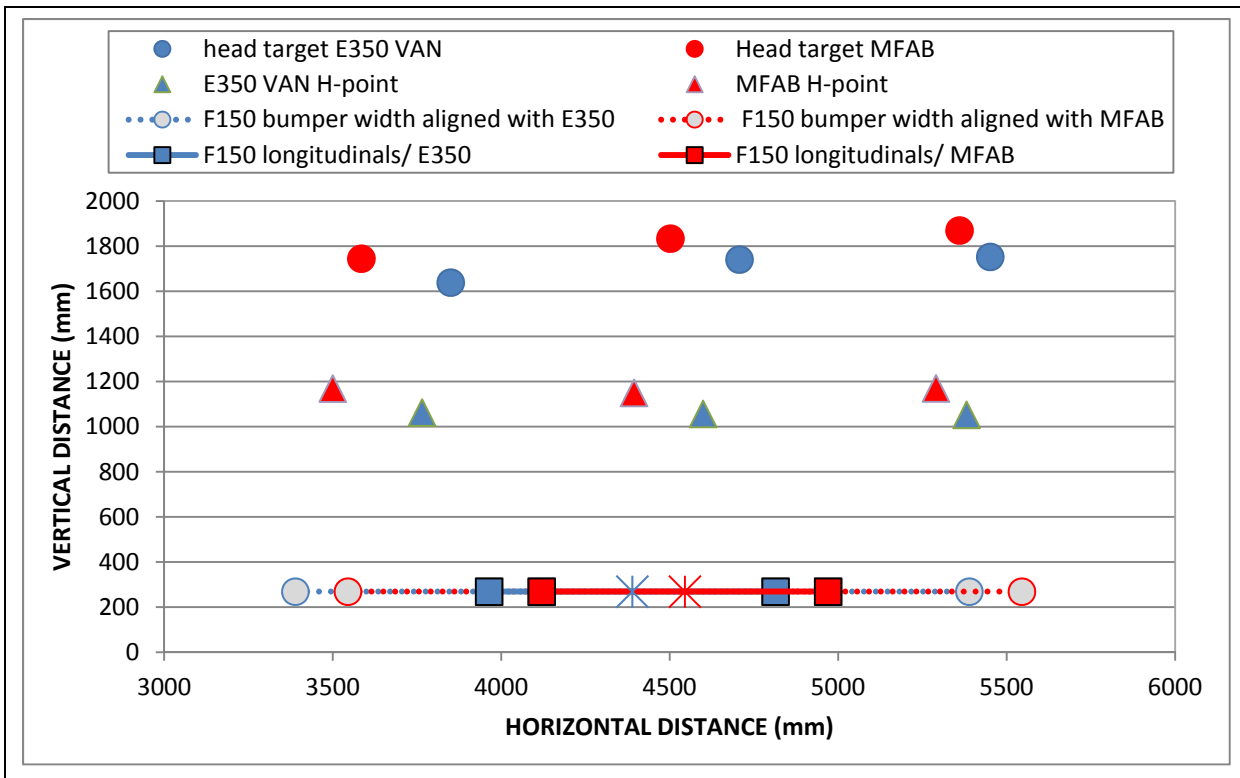
Figure 11. Relative positions of the head and hip targets of the struck side occupants with respect to bullet vehicle impact for the E350 van and MFAB.

Figure 11 is a plot documenting the dummy head and hip locations relative to the bullet vehicles. The head and hip target locations for the occupants seated on the struck side of the E350 van are represented by the solid blue circles and solid blue triangles respectively and

Generally, the dummy placement in the MFAB was more spread out than in the E350. The dummies in the MFAB are seated further forward relative to the front end of the F150 when compared to the relative positions of the dummies in the E350. The struck side dummies seated in the MFAB were located further forward than the dummies seated in the E350 with the greatest difference being observed between the two foremost occupants. In fact, the head of the foremost occupant in the MFAB was located approximately 535 mm forward of the closest striking longitudinal whereas the head of the dummy seated in the E350 was only 114 mm forward of the striking longitudinal. The distance between dummy occupants of the same row was also greater in the MFAB. For example, the distance between the head targets were on average, 500mm greater in the MFAB than in the E350.
