Four Square Home Inspections

Page 1 of 78
Sample Report - 2017.pt6

Property Address 1223 Any Street

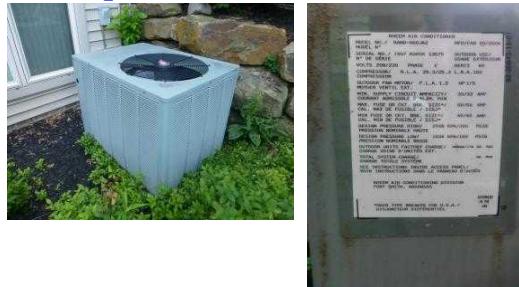
not be compatible with your equipment and system replacement will be required.

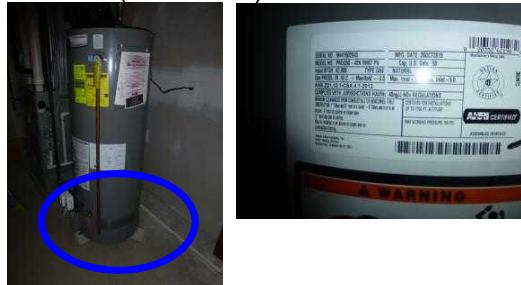
13. Manufacturer: Rheem
14. Model Number: PROG50-42N RH67 PV Serial Number: M441502943
15. Type: Draft induced unit (uses a fan to pull combustion gases through flue in center of tank). Draft -induced units are safer and more efficient than conventional water heater units by eliminating the draft diverter and therefore the unit uses far less indoor conditioned air for combustion and venting and provides a more reliable draft., Flammable Vapor Ignition Resistant unit (FVIR) 50 Gal.

16. Approximate Age: Date of manufacture = , 2 years Area Served: Entire home
17. Flue Connector Pipe: PVC piping for exhaust only
18. TPRV and Drain Tube: Copper Temperature Pressure Valve (TPR) is installed and appears visually to be operational. However, the actual valve has not been tested during this inspection. I recommend that a licensed or otherwise qualified plumber test this valve for proper operation prior to property purchase and on a regular basis thereafter (or alternatively, have it replaced periodically with a new unit) per the manufacturer's instructions. This valve is a critical safety device that, if it malfunctions, could result in unsafe temperature or pressure build-up in the water heater which can result in serious injury or death and/or serious property damage.
